Woodland Manor Sewer Pump Station & Tiogue Avenue Sewer Force Main, Coventry Rhode Island

Woodland Manor Sewer Pump Station

Located in Coventry, Rhode Island
Prepared For: HallKeen Real Estate
Management and Investment

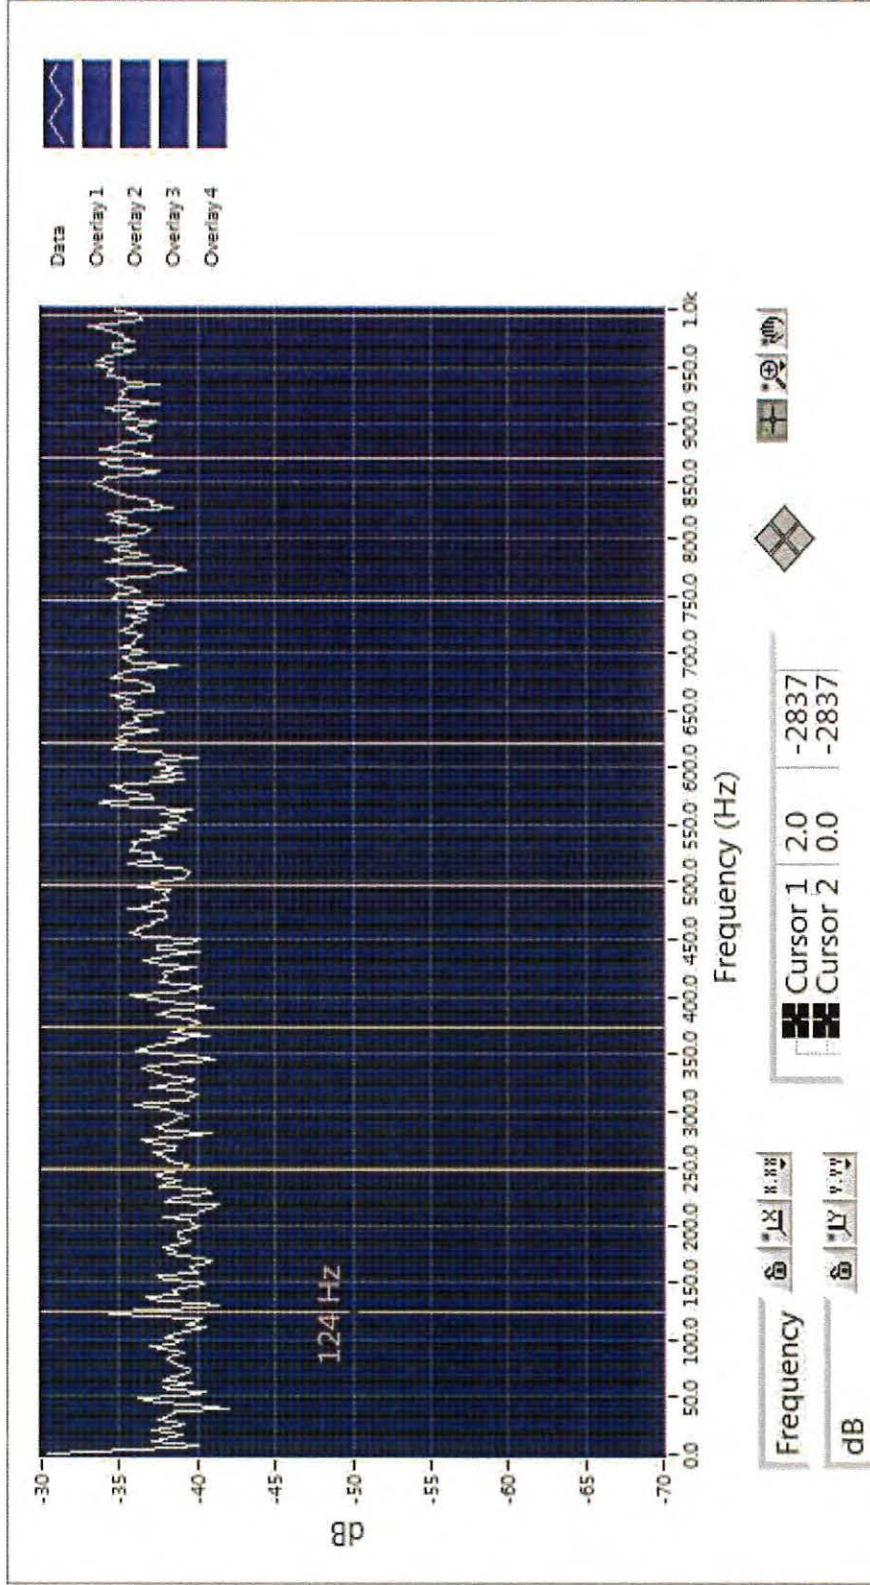
Exhibit 3

Pump 1B motor inboard bearing Small 124 Hertz Spike

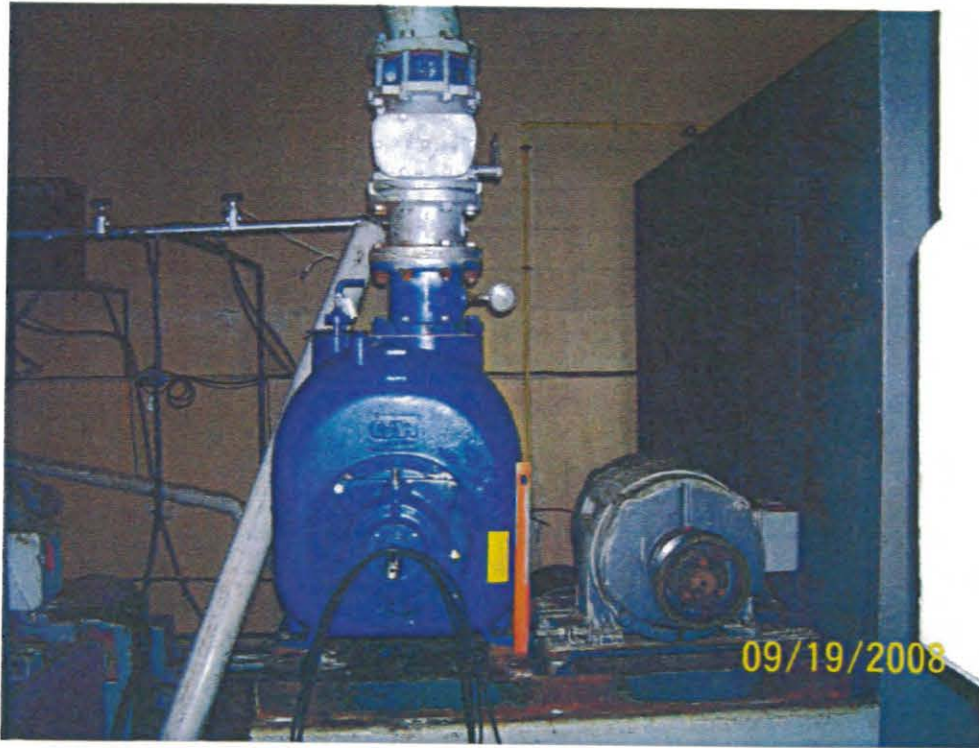
Figure 1: One of the G-RT6A3-B pumps

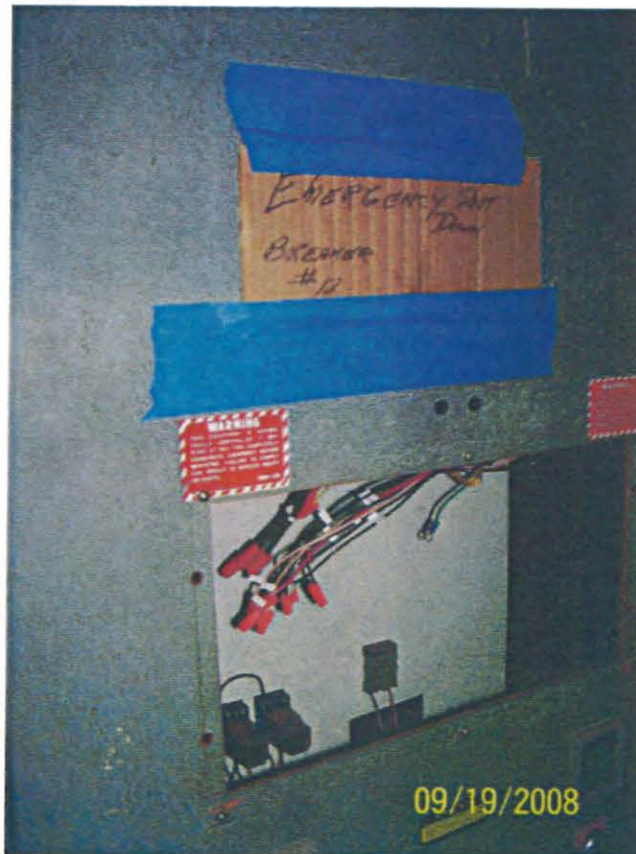
Figure 4: Missing float control panel (since repaired)

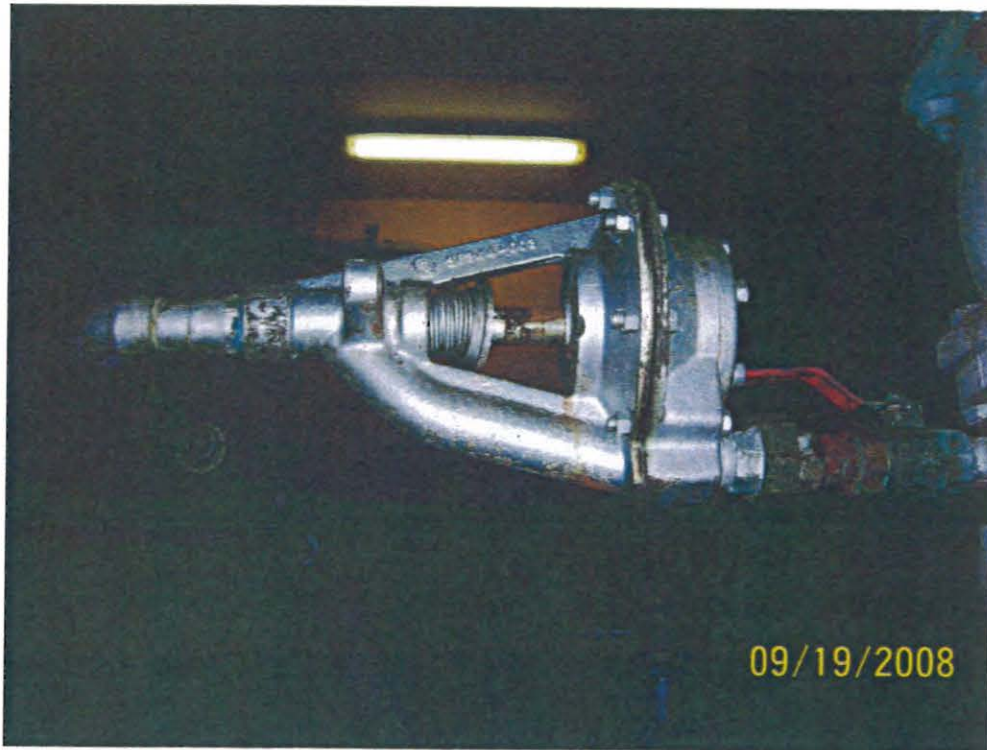
Figure 5: Combined air release

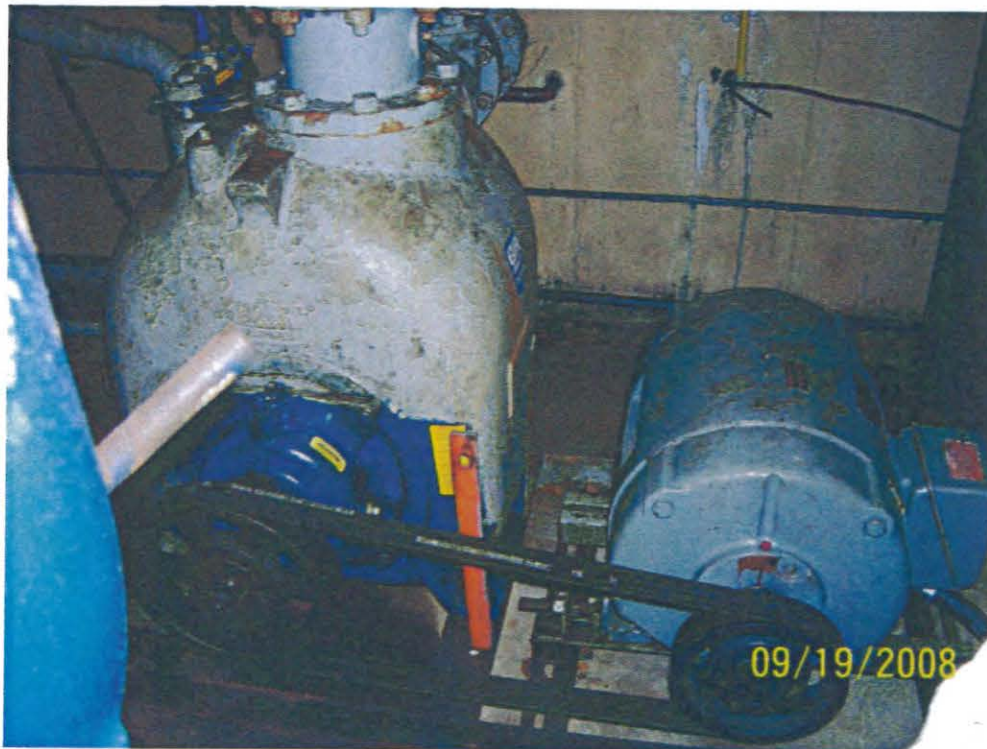
Figure 6: Pump in process of being repaired (since completed)

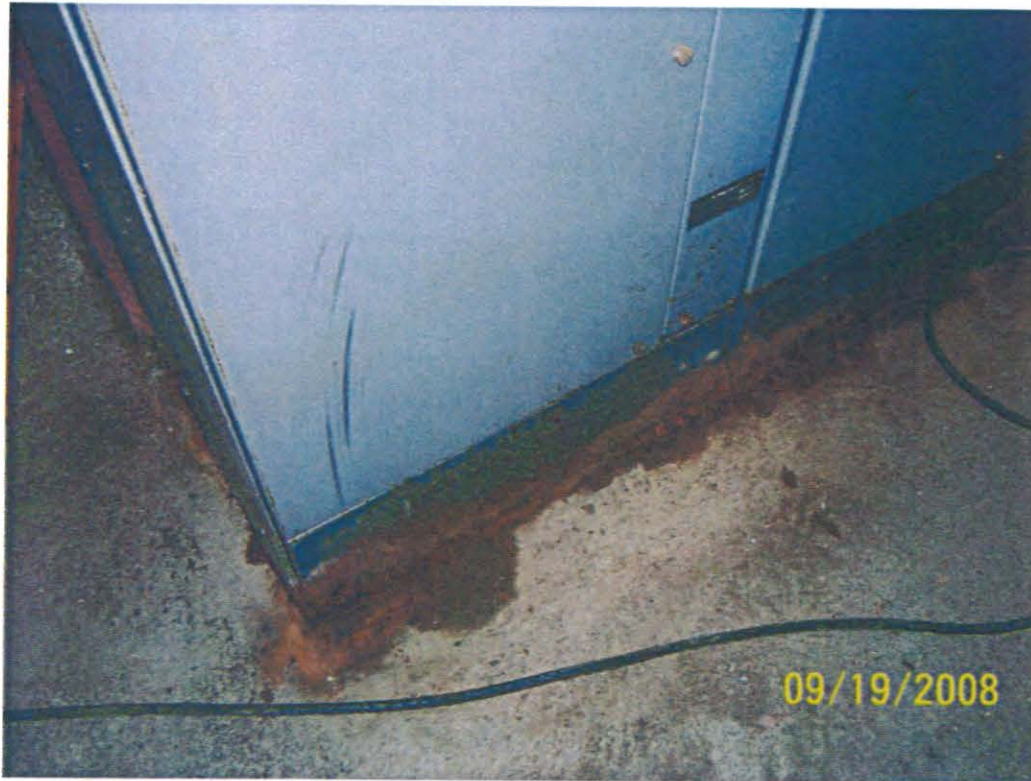
- The remaining set of pumps has been arranged to run on a temporary basis by a pair of float switches which run across the ground under the station's door and into the motor control center through the partially closed door on the Motor Control Cabinet (MCC). Floats are required due to the removal of the unoperational automatic level control system. The MCC is showing signs of age and corrosion along with extensive rusting on the lower portions of the steel cabinet.

Figure 8: Rust at bottom of control panel cabinet

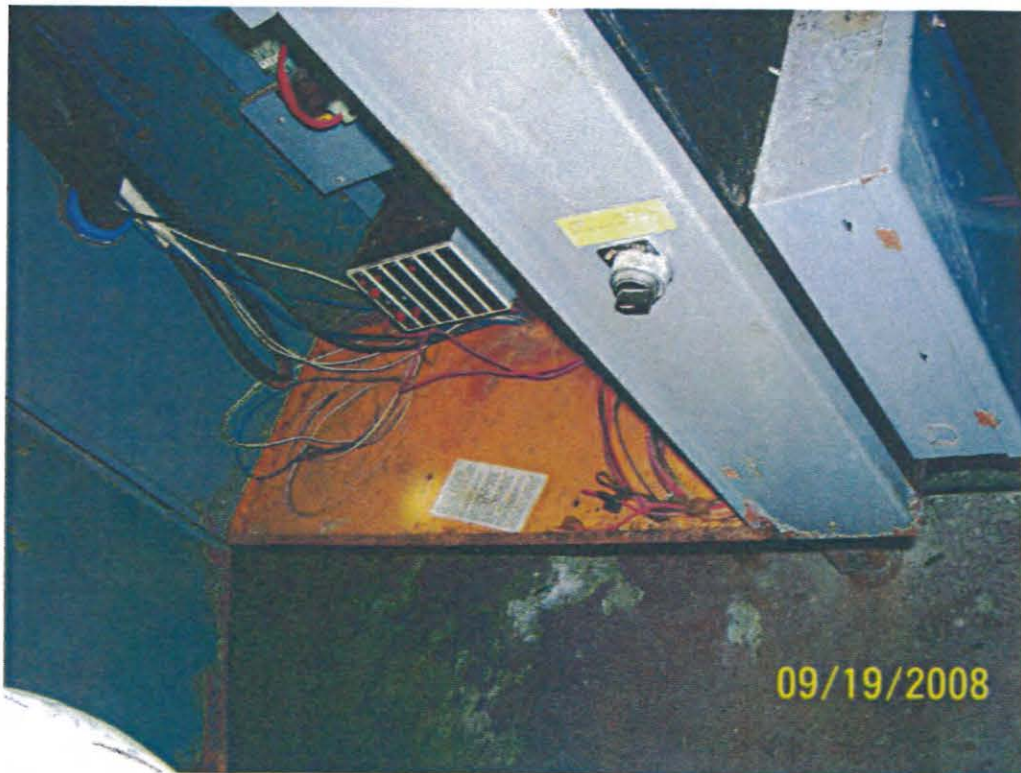
Figure 11: Inside of motor control center showing evidence of water pooling

- The Motor Control Center is of questionable reliability and it would require rebuilding or replacement if it is to be counted on to provide satisfactory service.
- The air release valve line running out of the pump station is currently split and attached to both series of pumps.
- The water supply to the building is located at the bottom of the stairs roughly six inches off the ground.
- Other problems within the station include lack of any system to lift or hoist pumps into place, failing lights, leaking chemical piping, and other housekeeping issues.
- A source of backup power was not observed and it is not clear how the station would remain functional during a power loss.

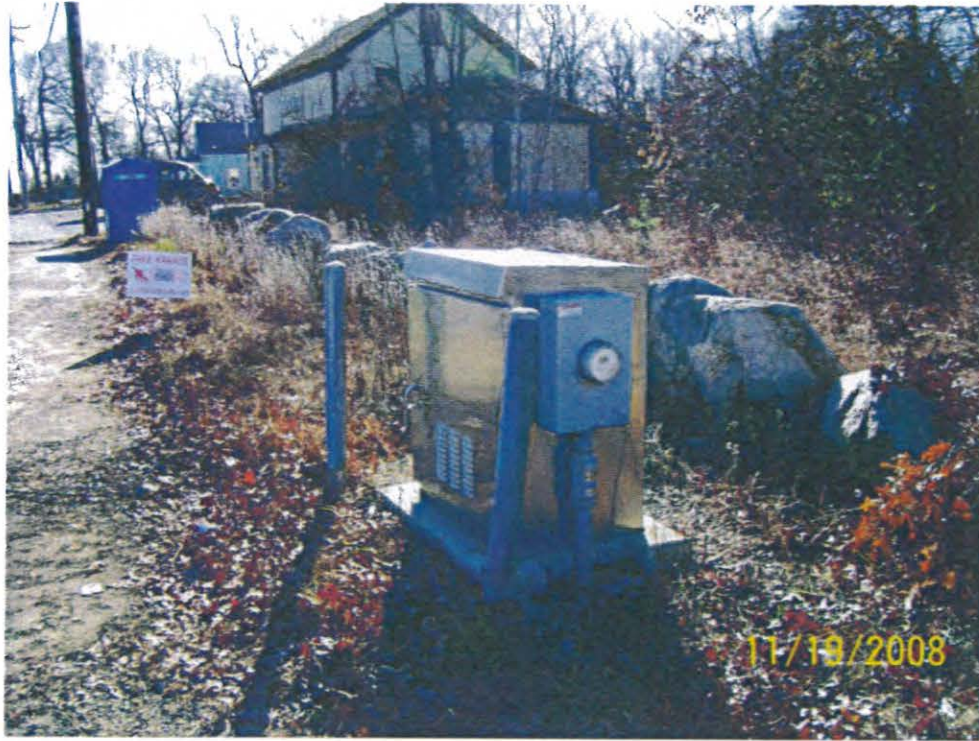
Figure 12: Sewer force main meter enclosure located on Tiogue Avenue

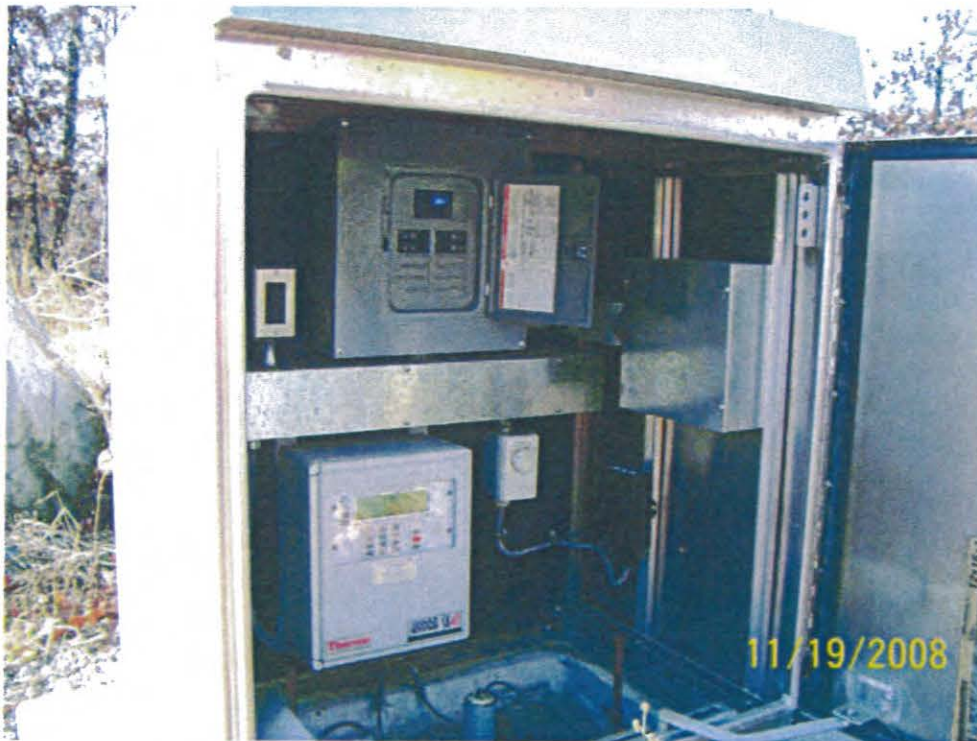
Figure 13: Inside of meter cabinet

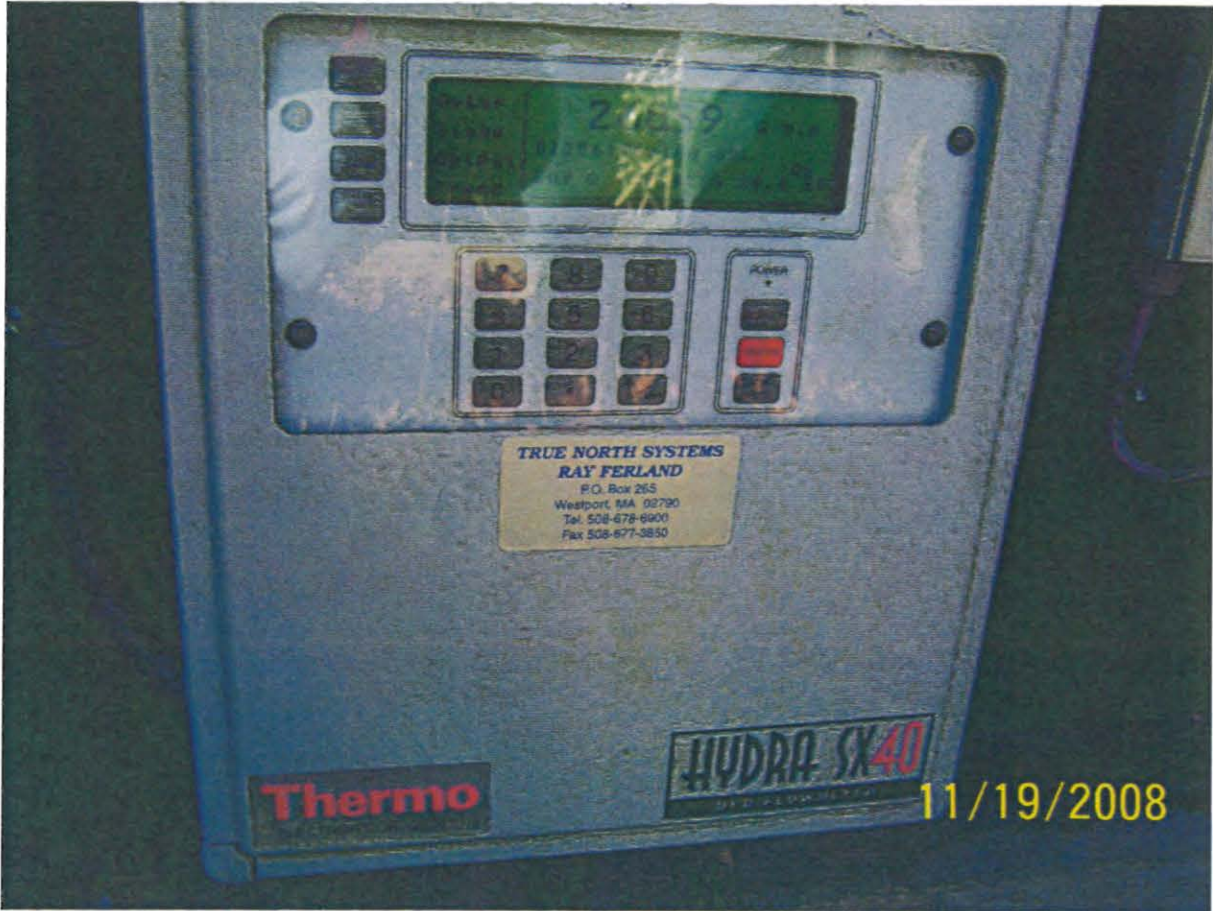
Figure 14: Sewer force main meter
