Arnold Road, New London Turnpike, and Centre of New England Boulevard

E Flat River Road at Plainfield Pike

Western Coventry Elementary

H Main St and South Main St – Dave's Marketplace

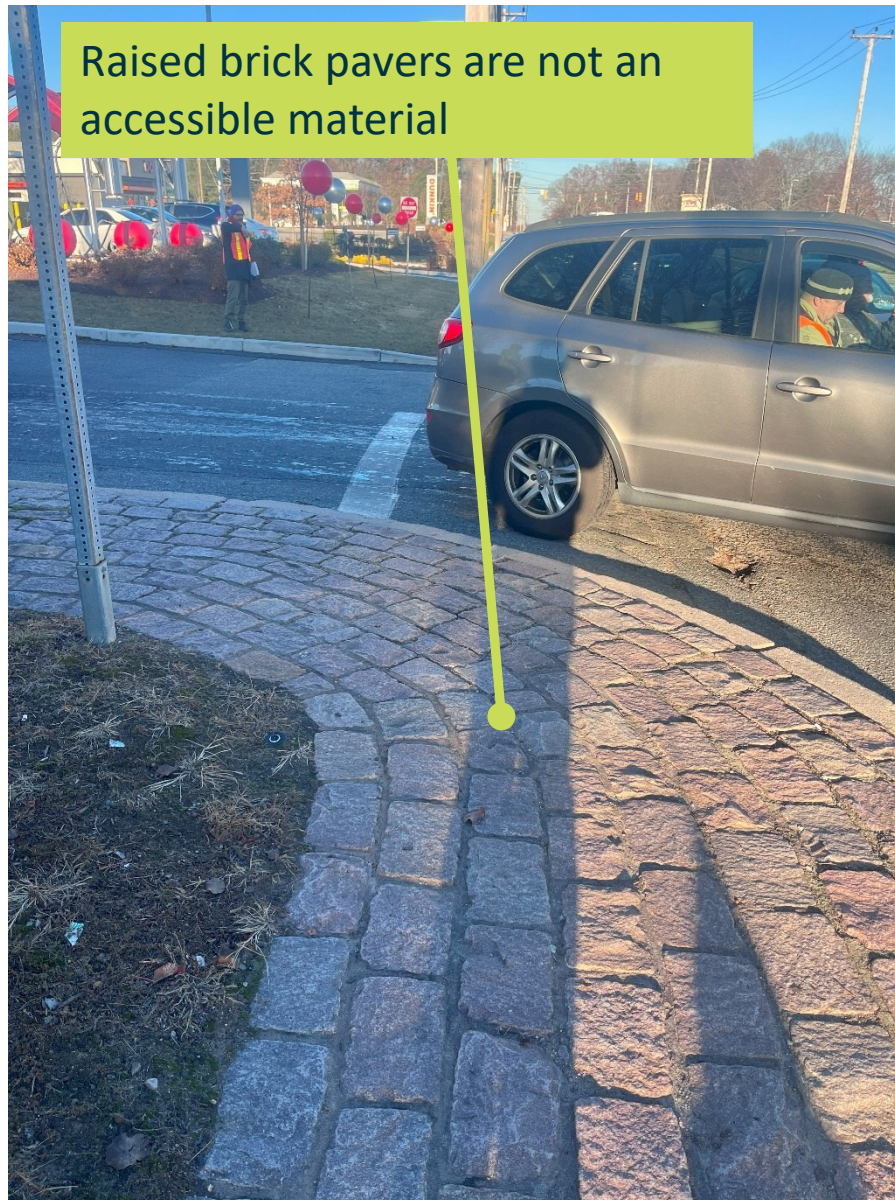
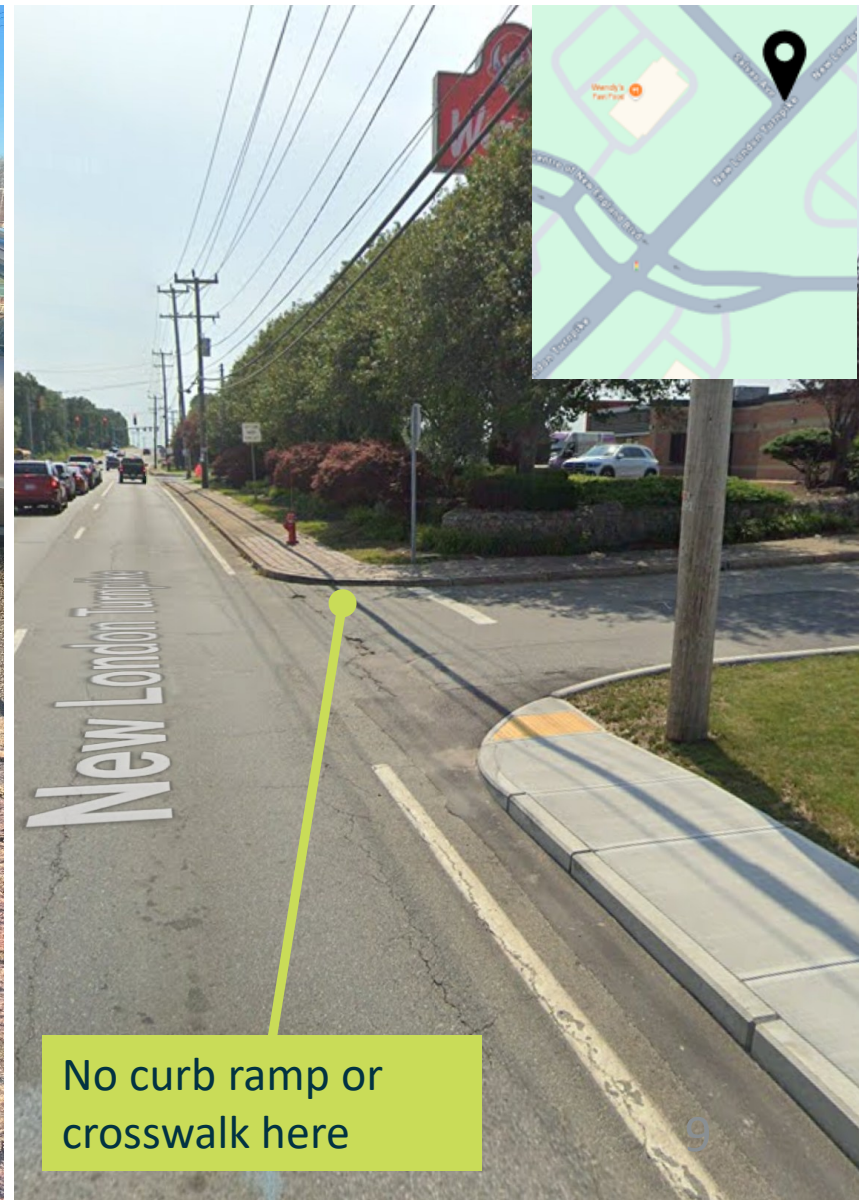
- Inconsistent sidewalk materials used
- Rough edged brick pavers are not suitable nor ADA compliant
- No crosswalk or curb ramp across Salvas Ave
- Intersection only has 1 crosswalk out of 4 crossings (missing ped signals and curb ramps)

Raised brick pavers are not an accessible material

No curb ramp or crosswalk here

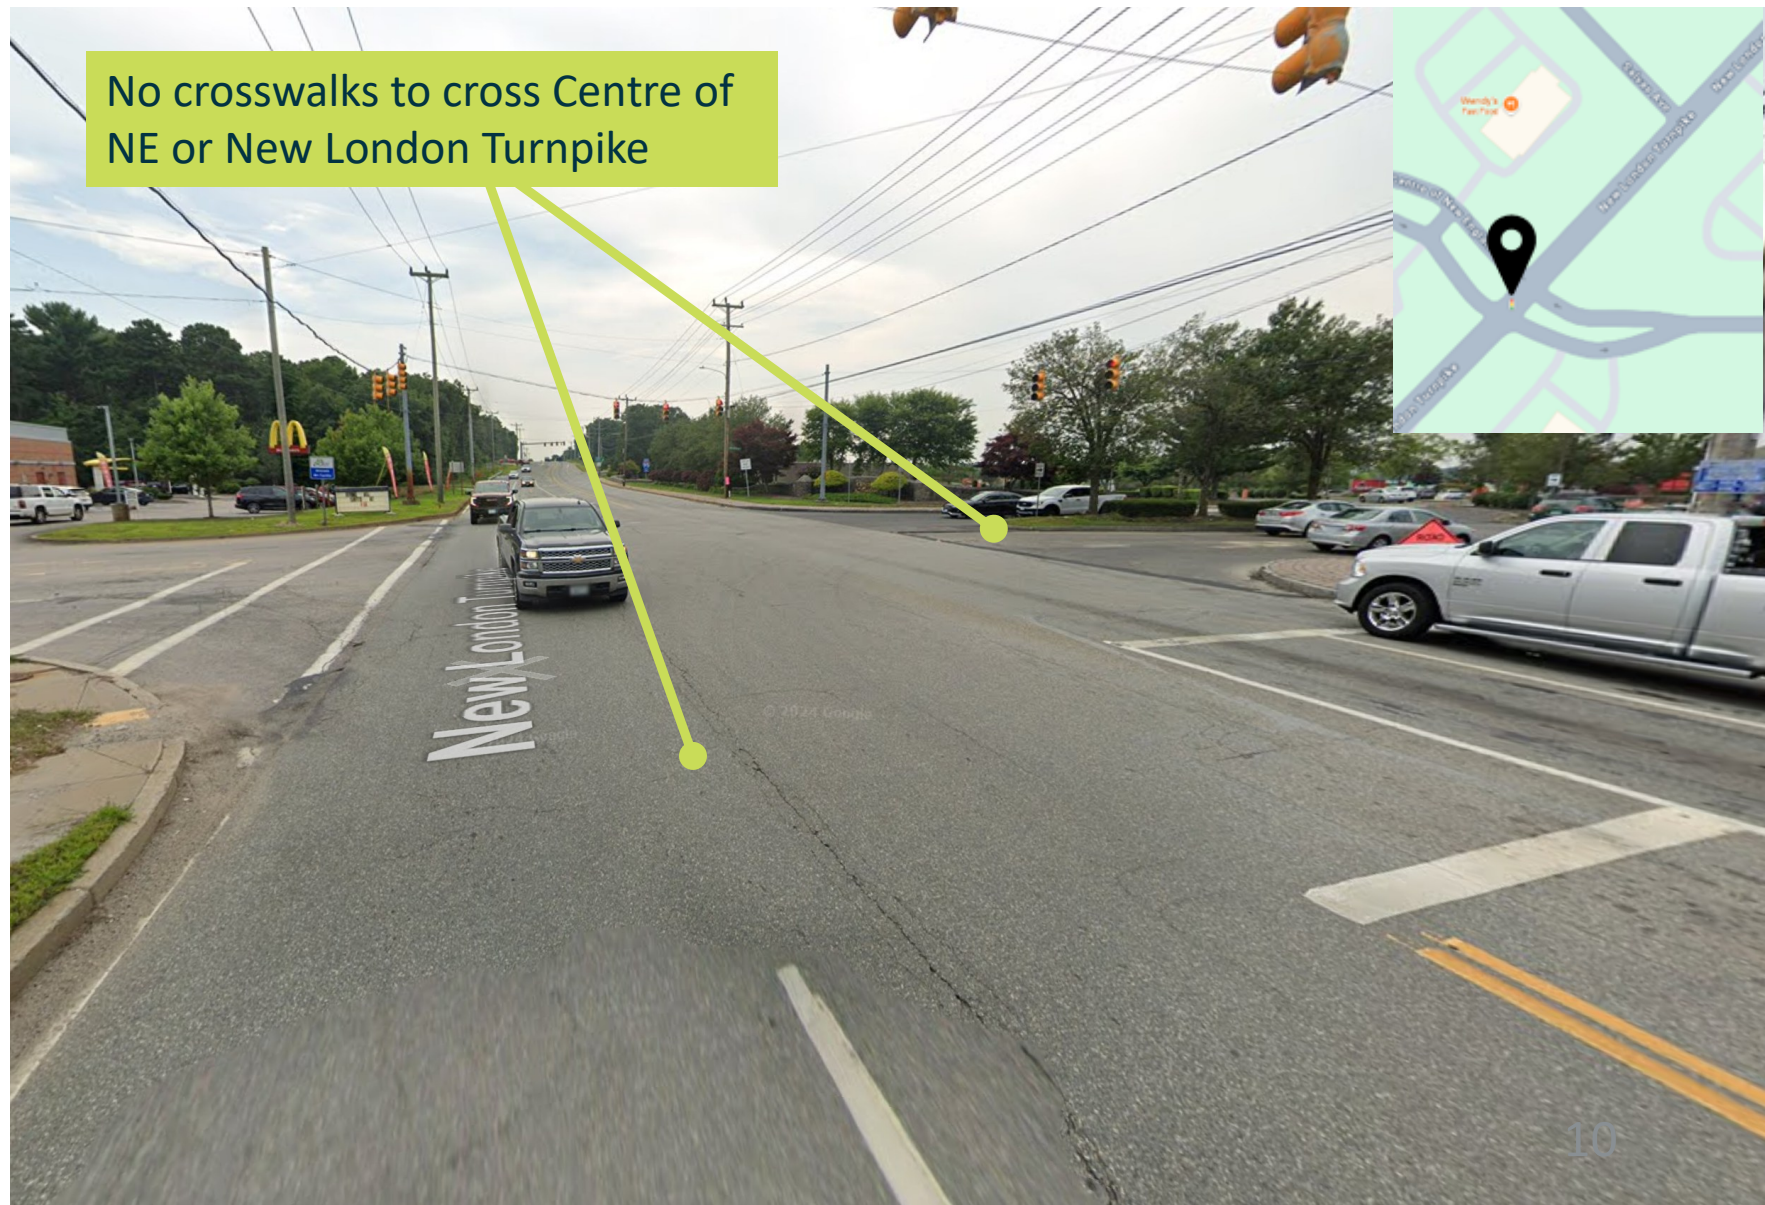
- Inconsistent sidewalk materials used
- Rough edged brick pavers are not suitable nor ADA compliant
- No crosswalk or curb ramp across Salvas Ave
- Intersection only has 1 crosswalk out of 4 crossings (missing ped signals and curb ramps)

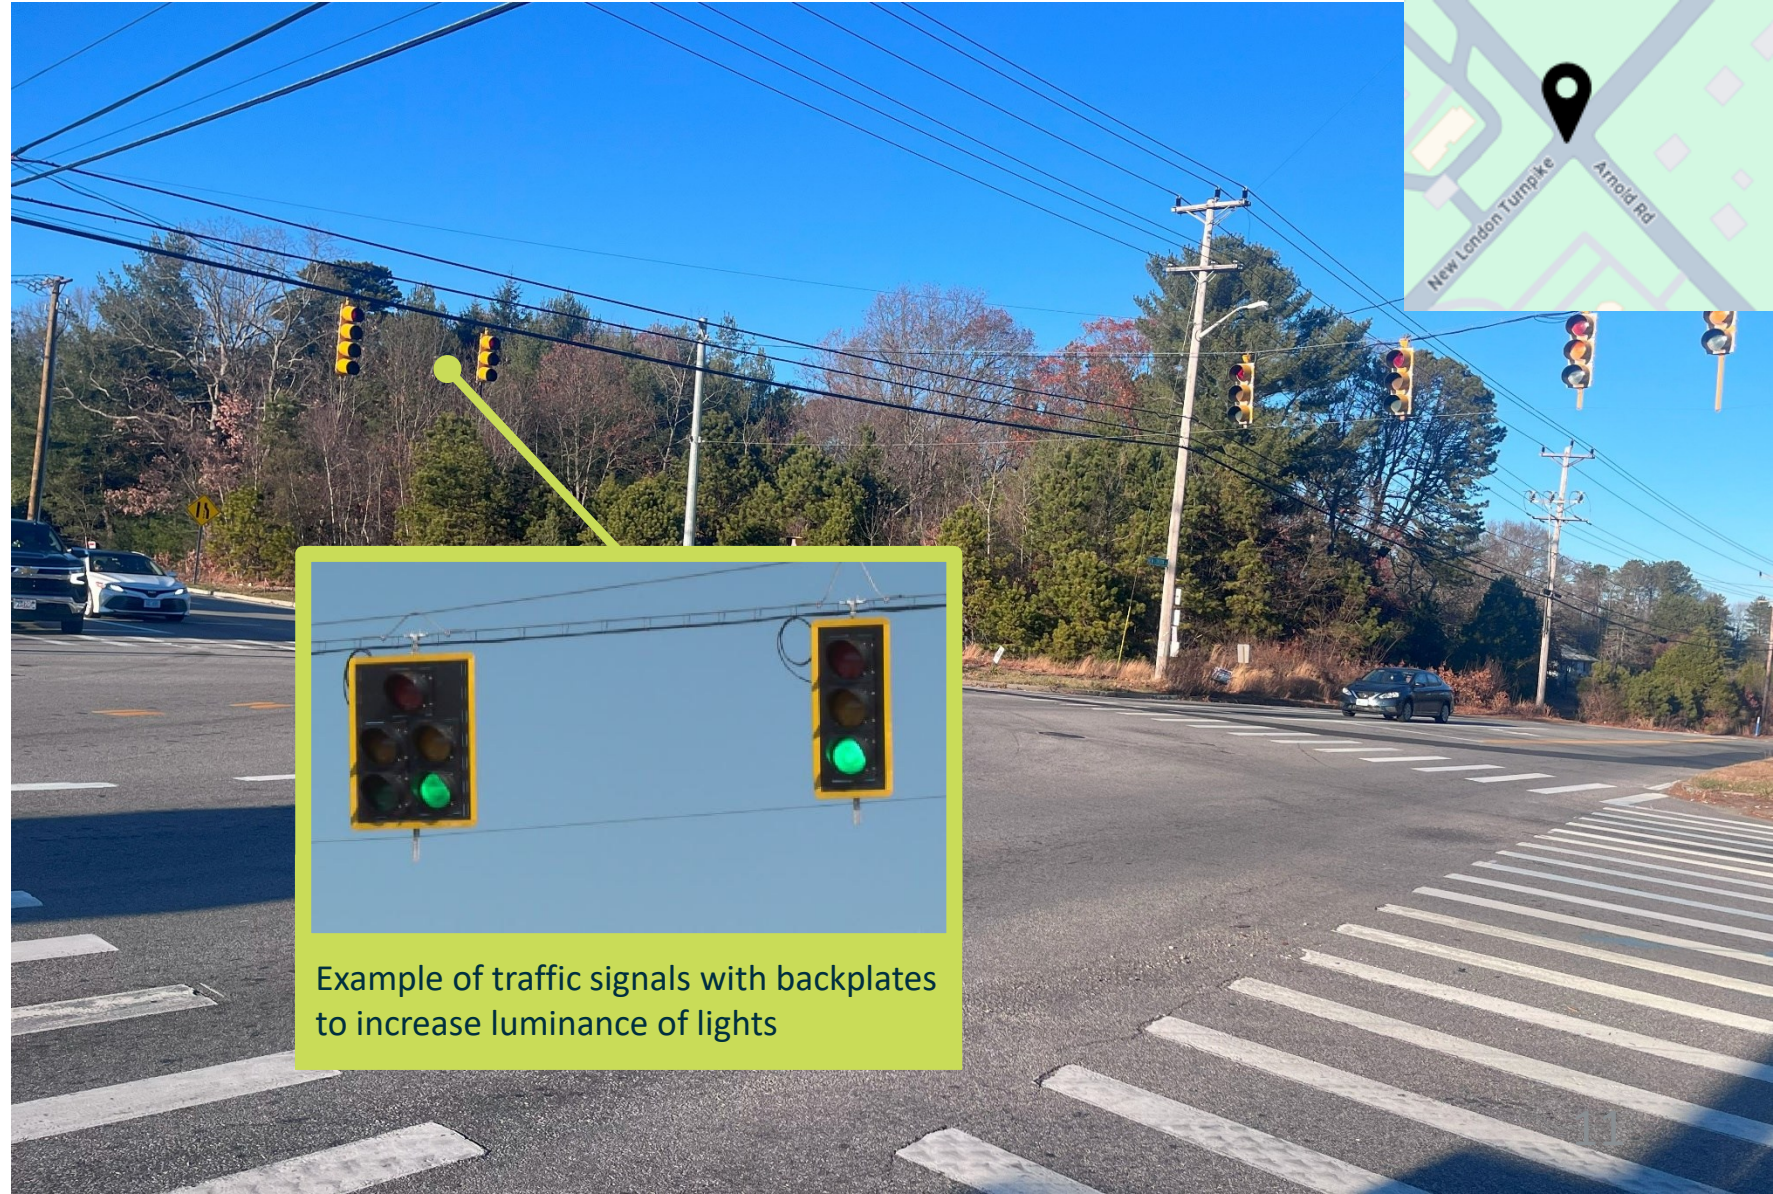
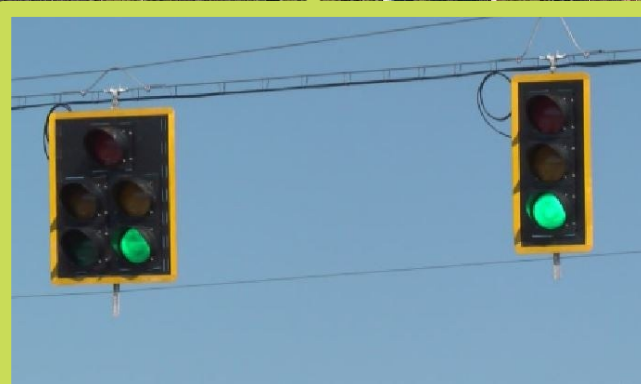
Example of traffic signals with backplates to increase luminance of lights

- **Verify loading capacity of mast arms and add backing plates to all signals to increase luminosity**
- Institute No Turn on Red policy or add Yield to Pedestrian sign

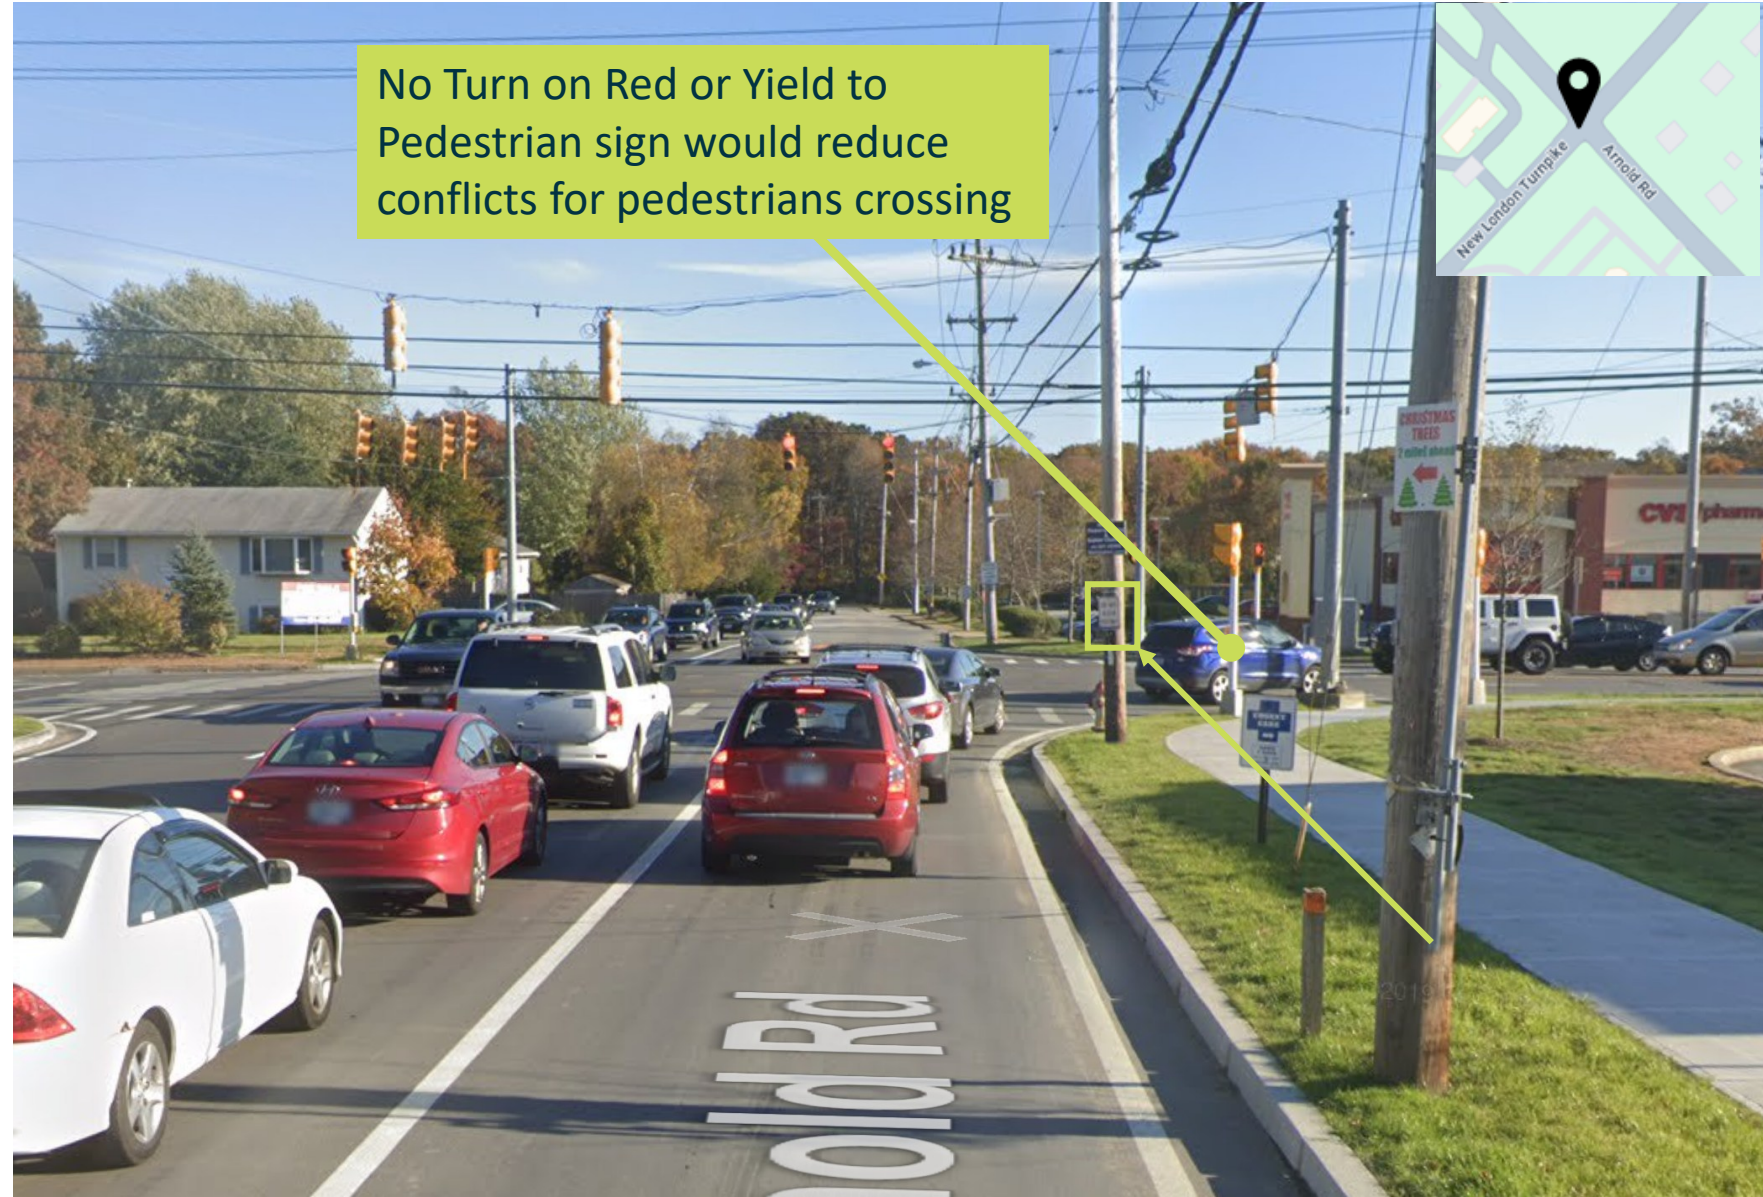
No Turn on Red or Yield to Pedestrian sign would reduce conflicts for pedestrians crossing

- Add backing plates to all signals to increase luminosity
- **Institute No Turn on Red policy or add Yield to Pedestrian sign**

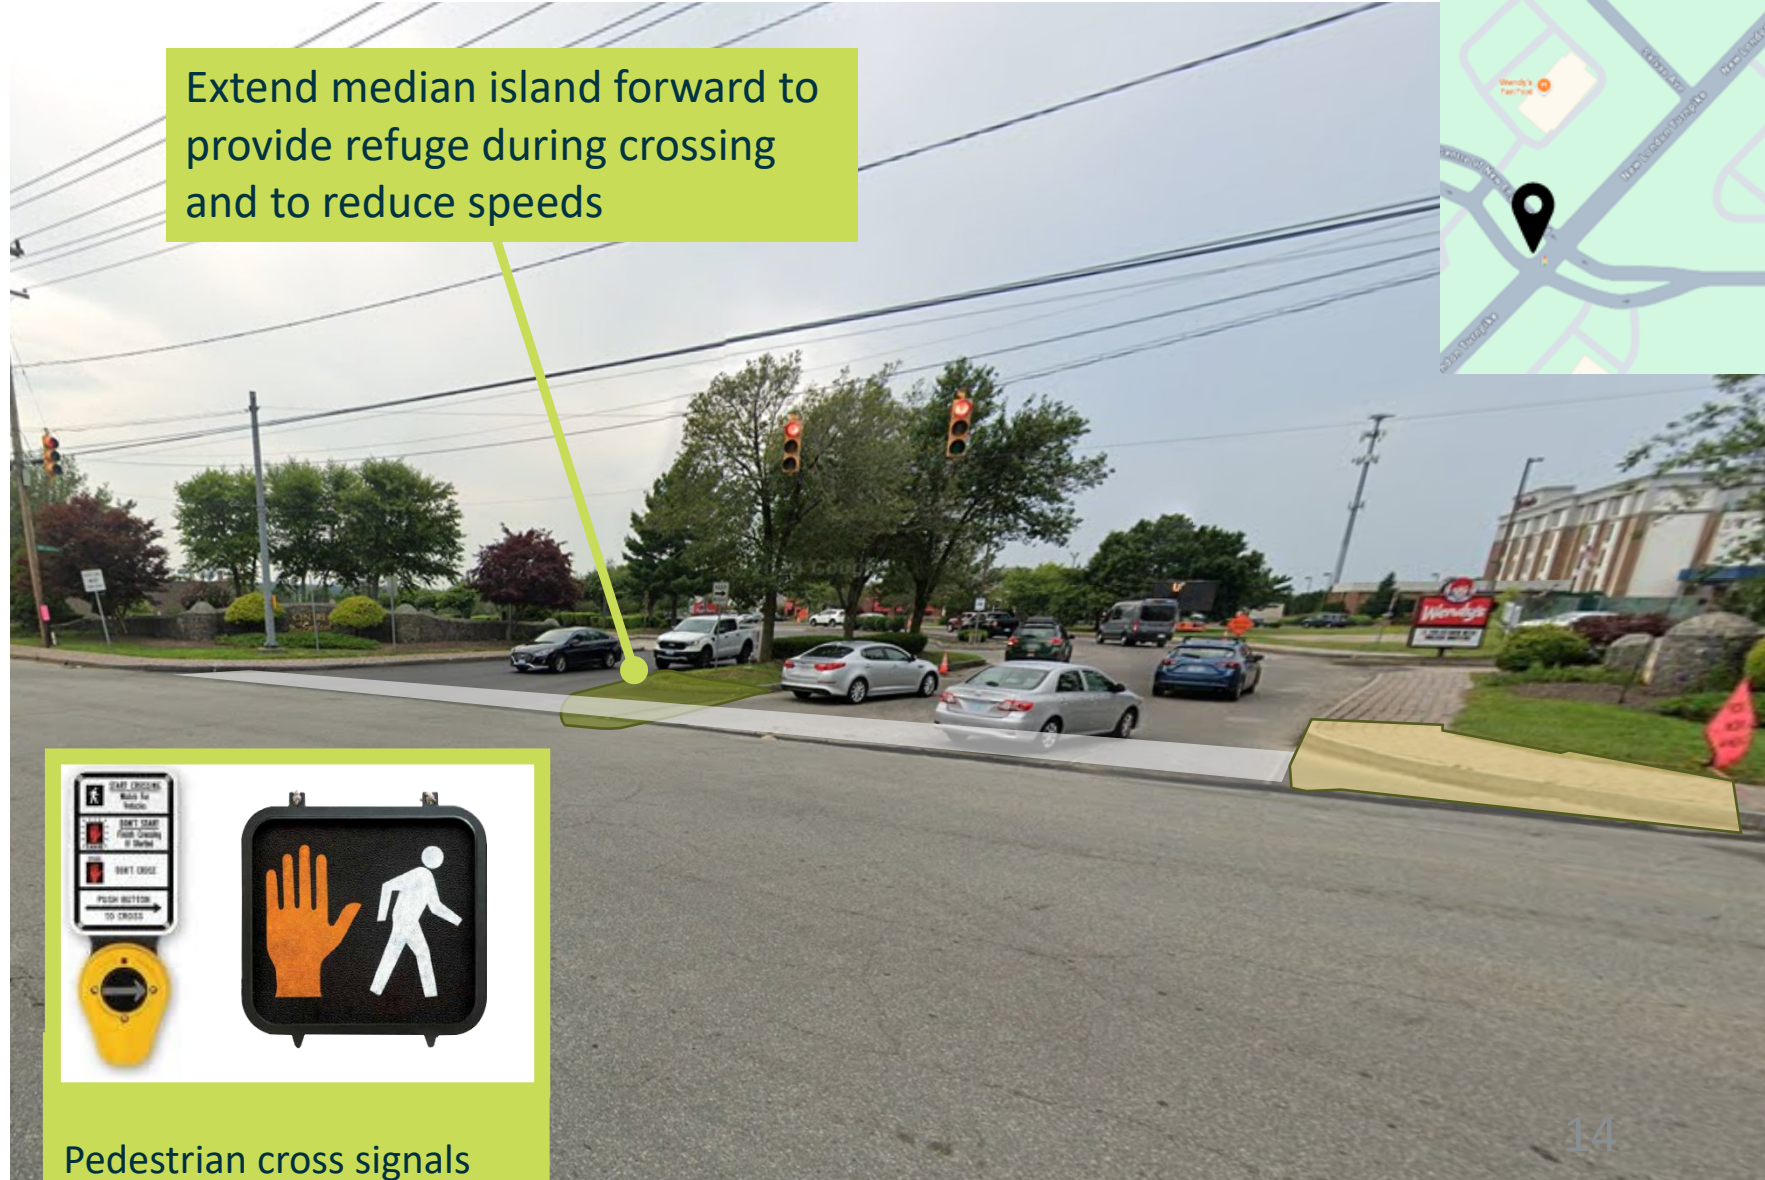
Extend median island forward to
provide refuge during crossing
and to reduce speeds

Pedestrian cross signals

- Add crossings on all intersection legs with appropriate infrastructure for crosswalks, curb ramps, and ped signals

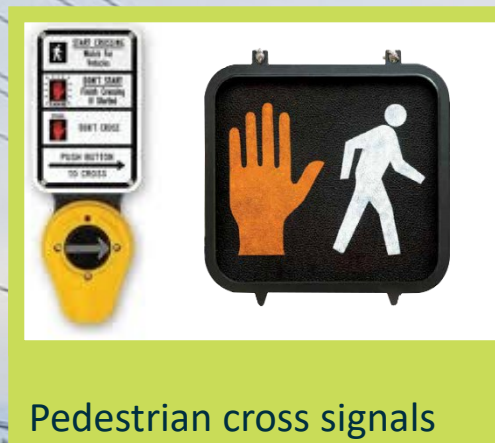
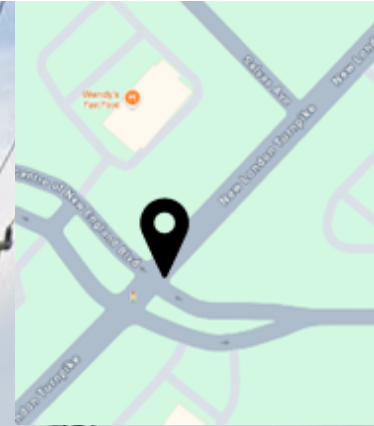
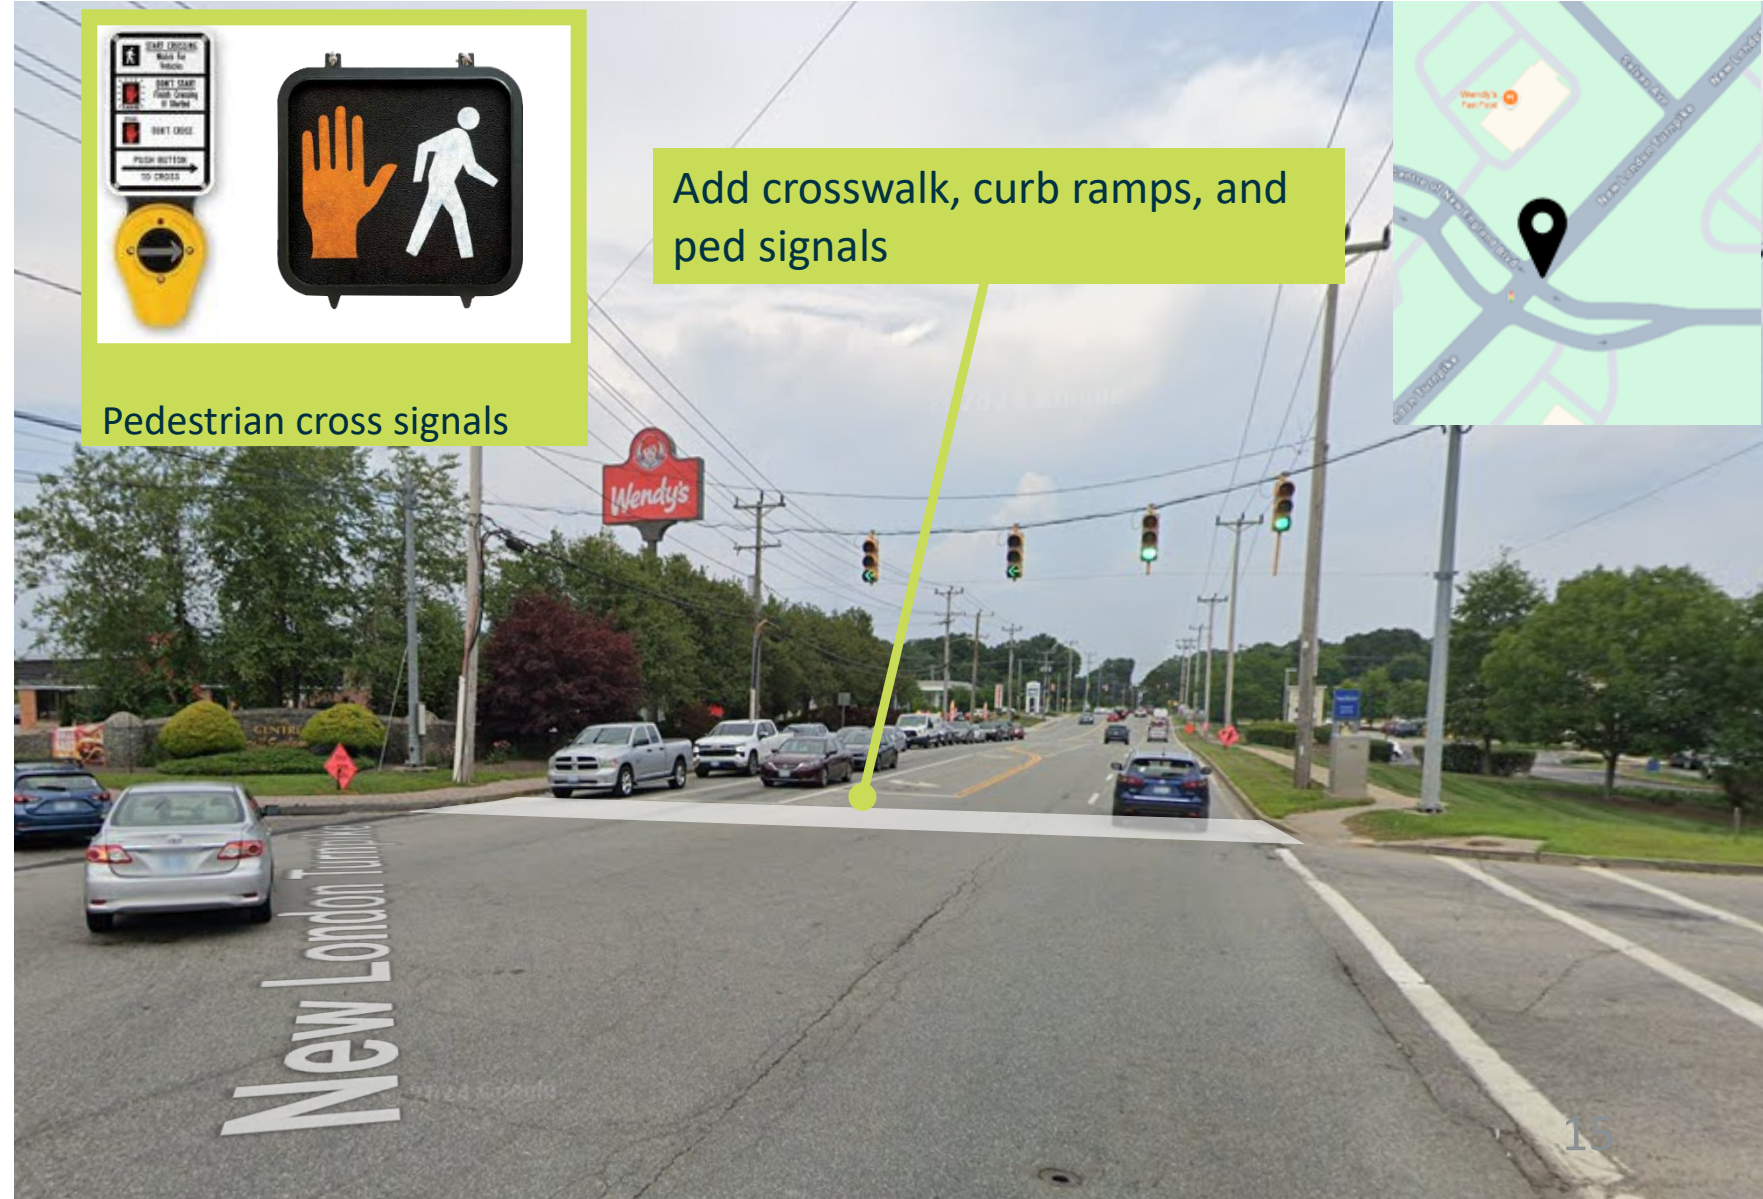
Pedestrian cross signals

- Add crossings on all intersection legs with appropriate infrastructure for crosswalks, curb ramps, and ped signals

Add crosswalk, curb ramps, and ped signals

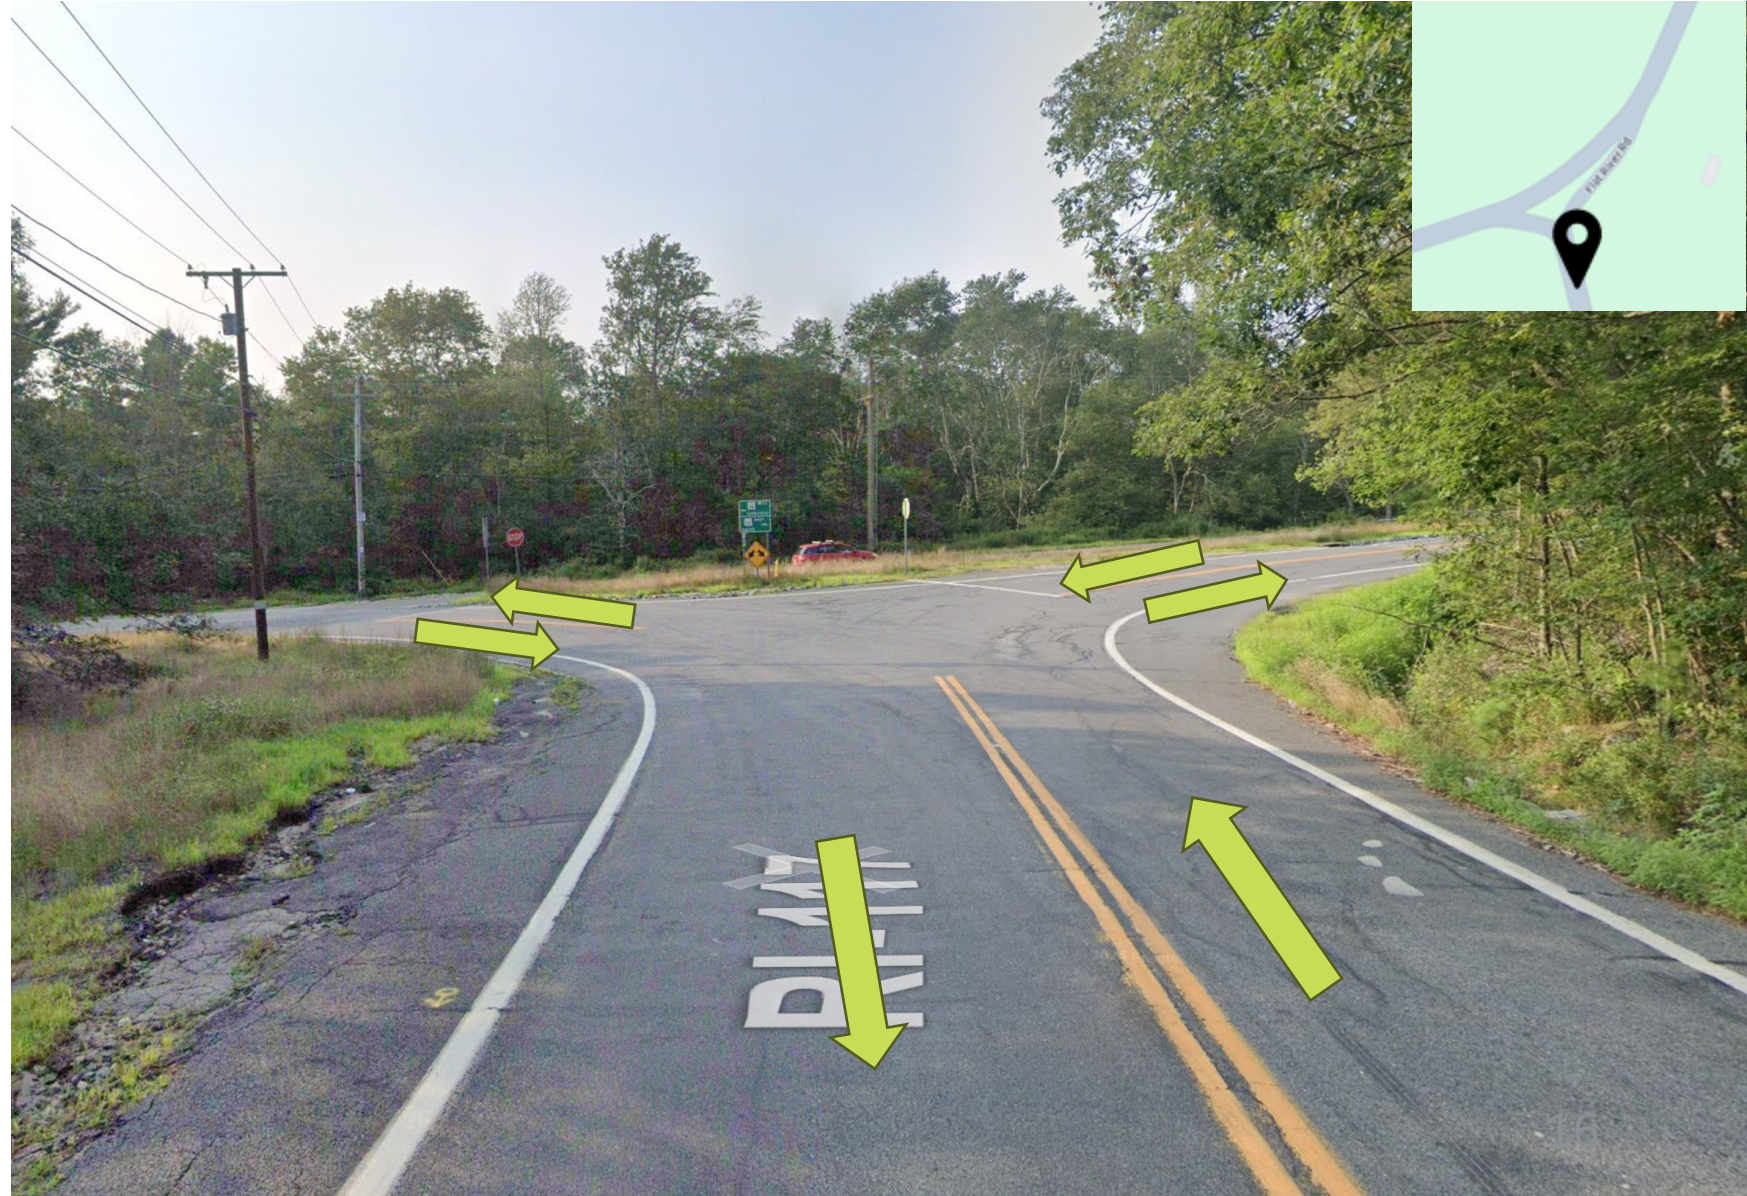
- 3- way intersection, with 2-way “slip lanes” branching off Route 117
- Creates more conflict points than a typical 3-way intersection
- Confusing intersection for drivers not familiar with the area

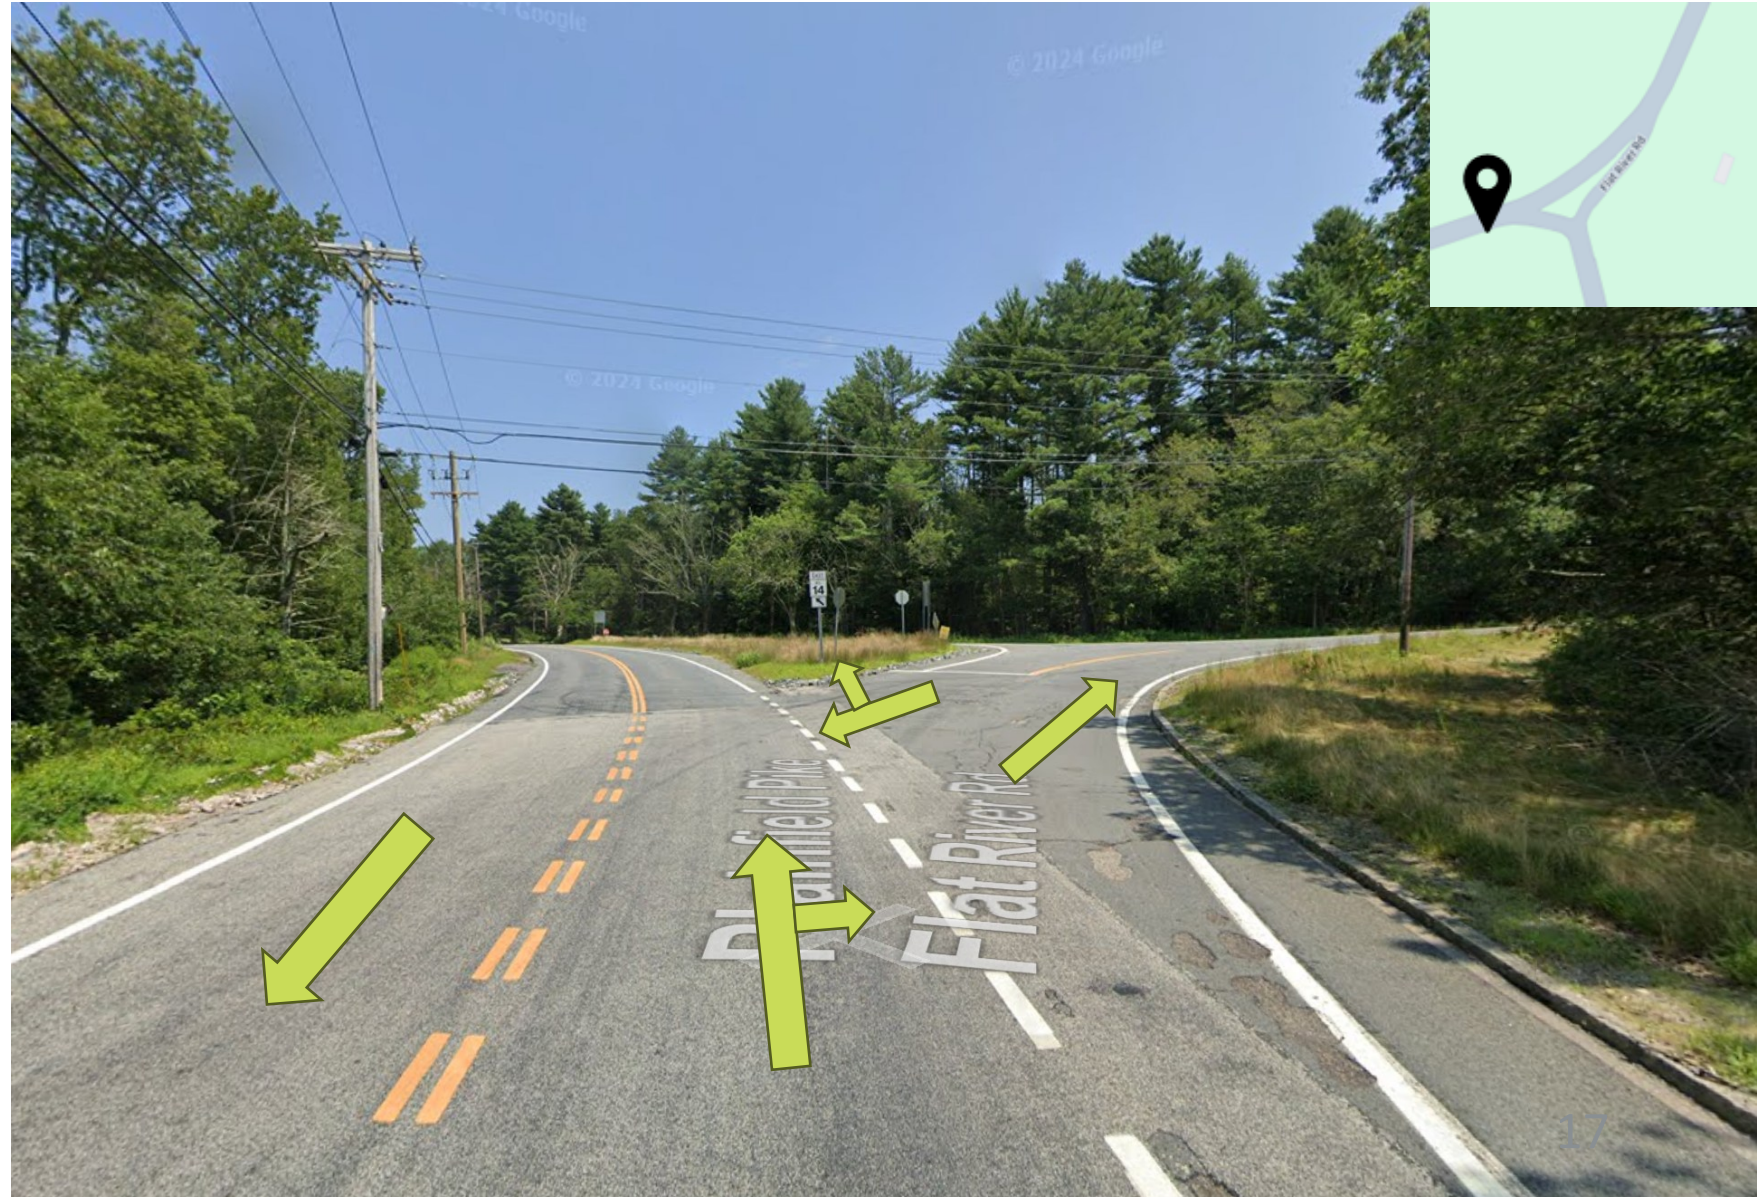
- 3- way intersection, with 2-way “slip lanes” branching off Route 117
- Creates more conflict points than a typical 3-way intersection
- Confusing intersection for drivers not familiar with the area

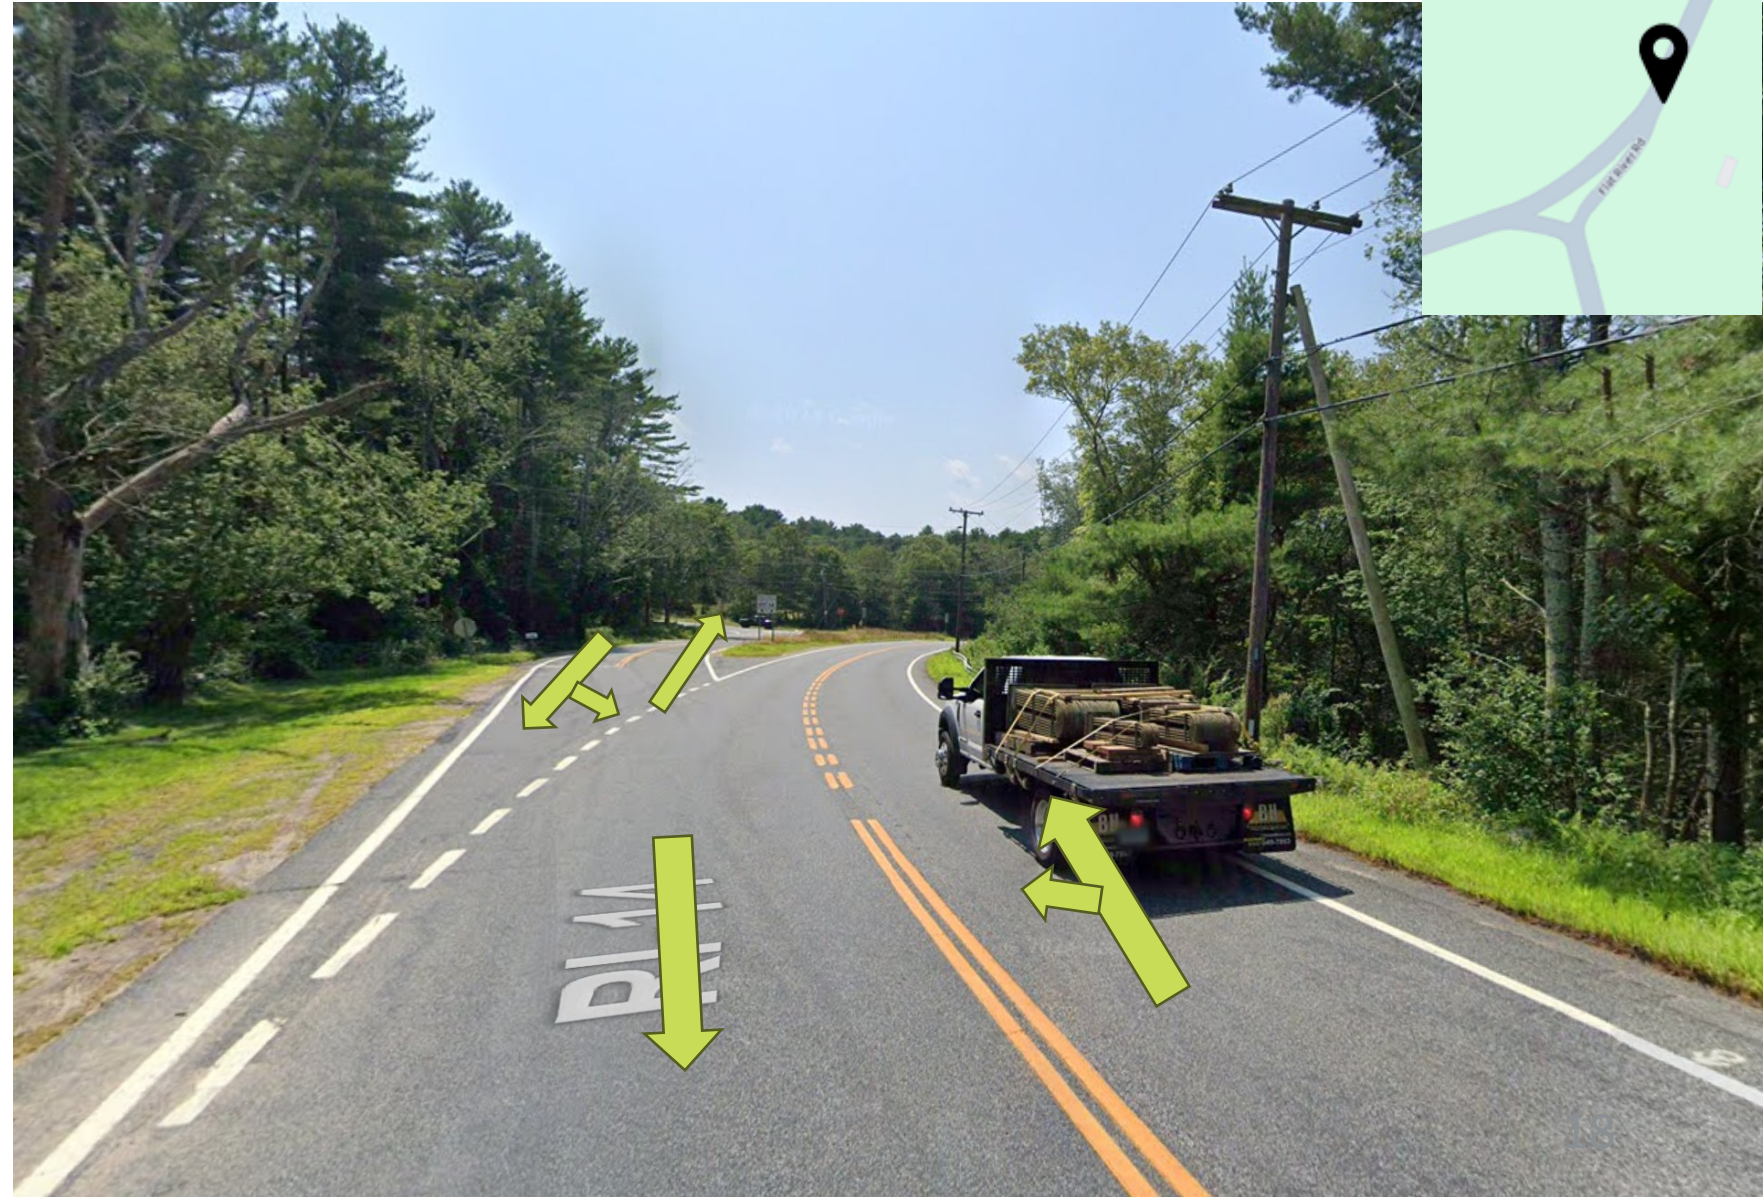
- 3- way intersection, with 2-way “slip lanes” branching off Route 117
- Creates more conflict points than a typical 3-way intersection
- Confusing intersection for drivers not familiar with the area

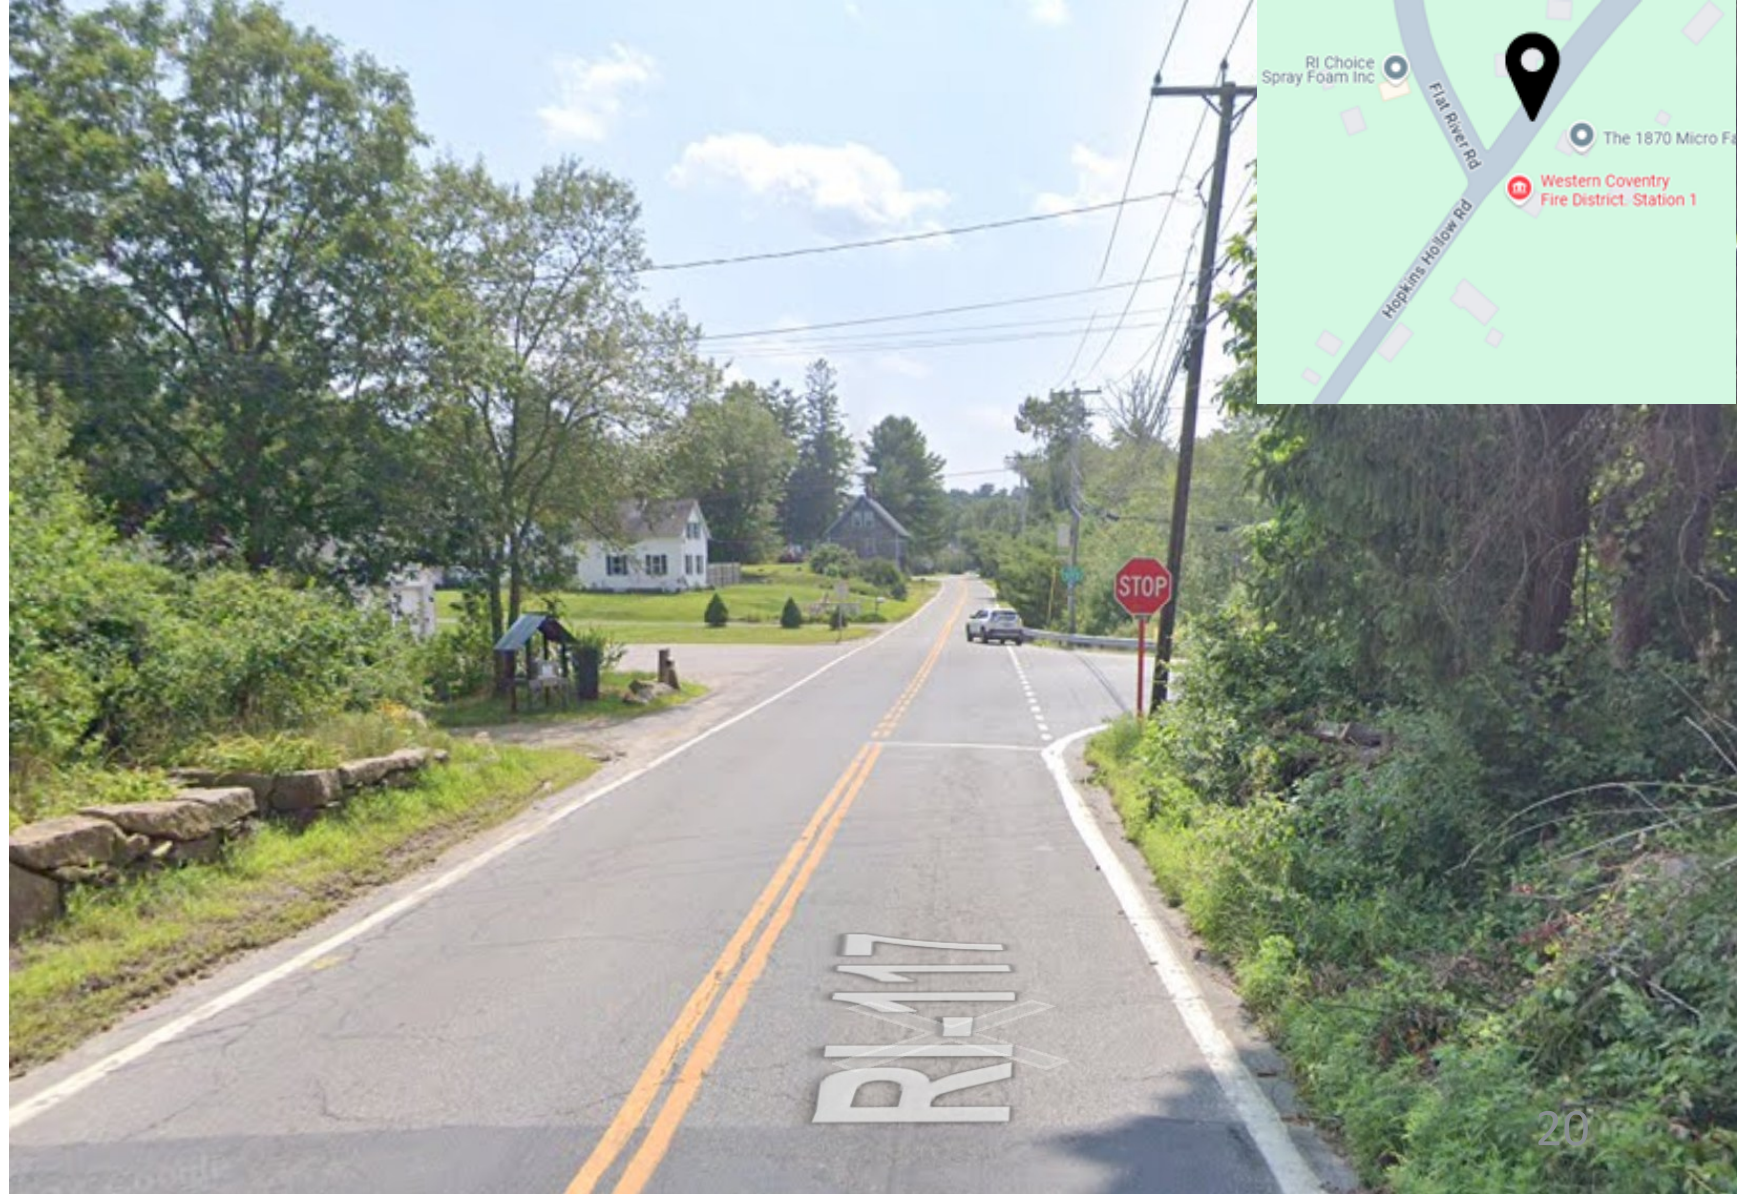
- 3 way stop controlled intersection
- **Sharp turn to stay on Flat River Rd (Route 117)**
- Vegetation extends into sightlines
- Intersection is in a rural area, no roadway lighting or pedestrian accommodations
