Arnold Road, New London Turnpike, and Centre of New England Boulevard

E Flat River Road at Plainfield Pike

Western Coventry Elementary

H Main St and South Main St – Dave's Marketplace

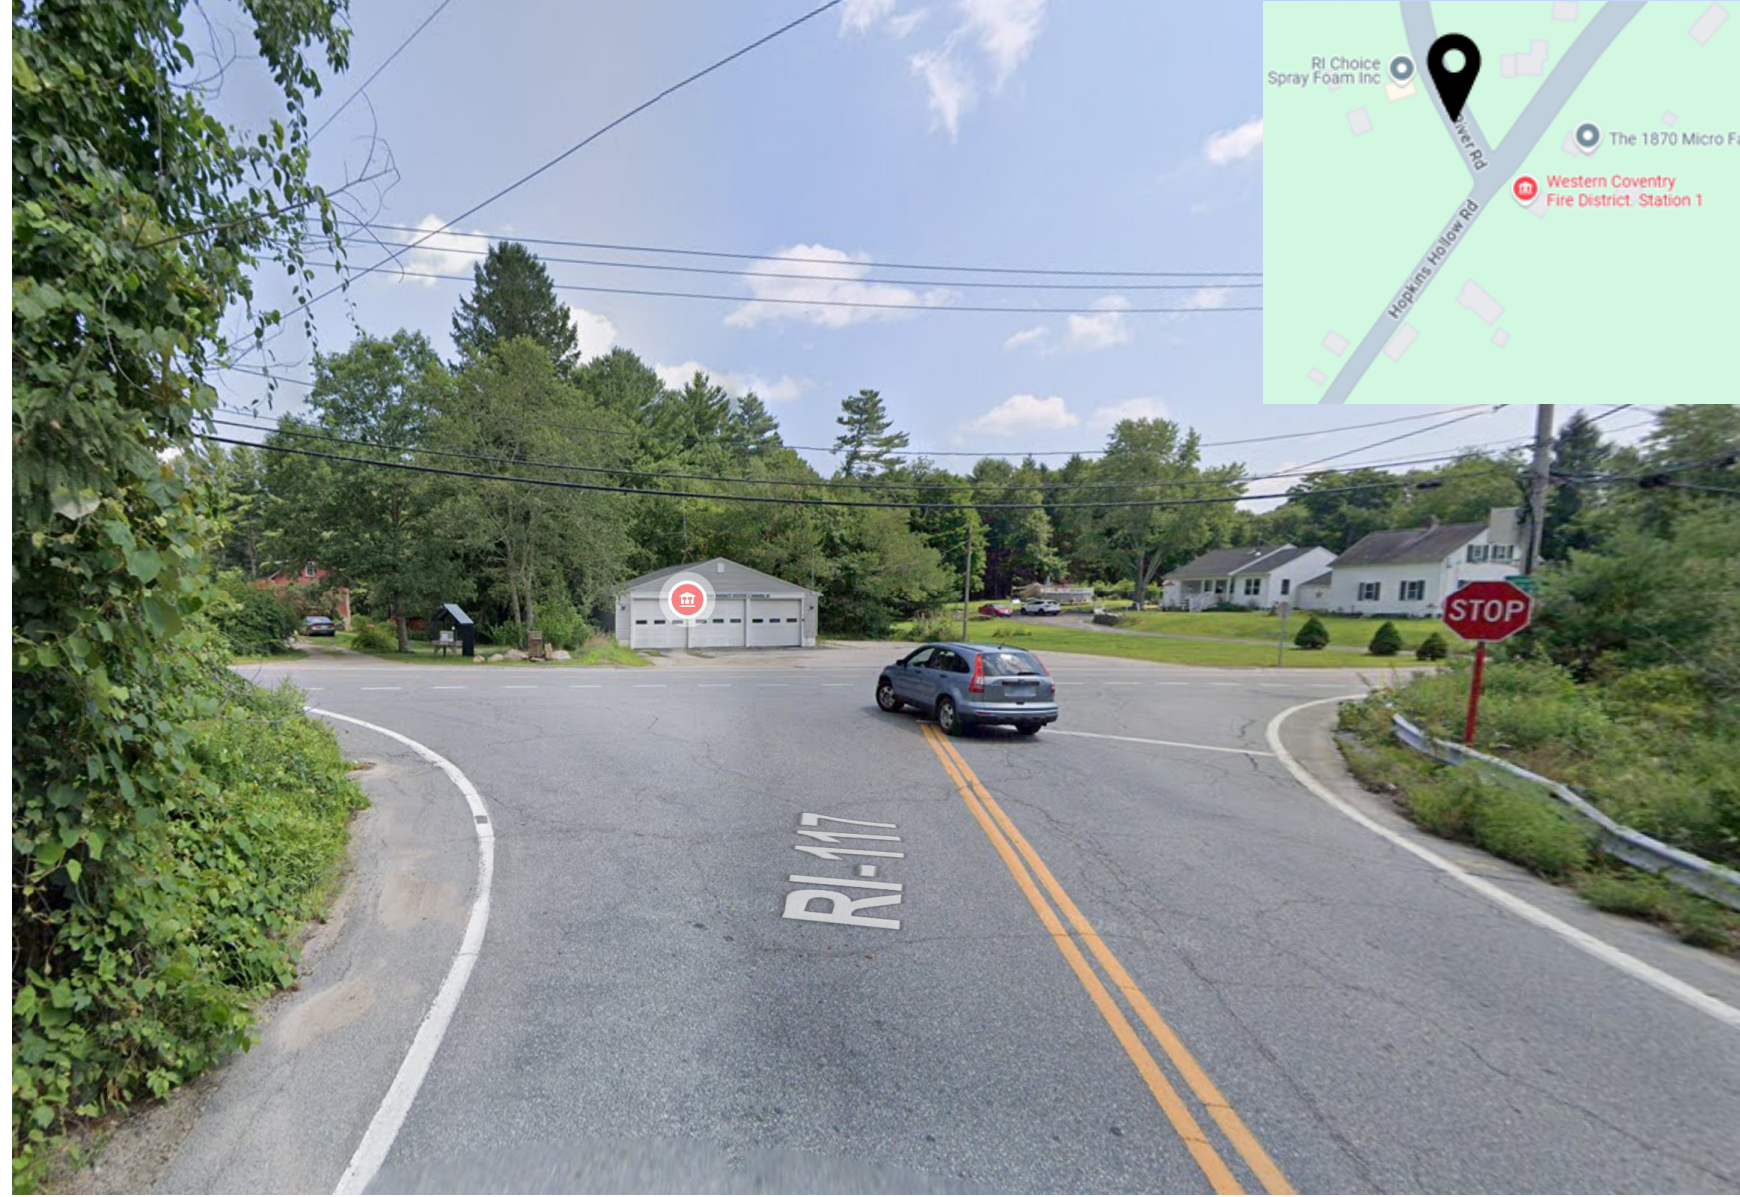
- 3 way stop controlled intersection
- Sharp turn to stay on Flat River Rd (Route 117)
- **Vegetation extends into sightlines**
- Intersection is in a rural area, no roadway lighting or pedestrian accommodations

- Trim vegetation regularly to improve sightlines on left turns

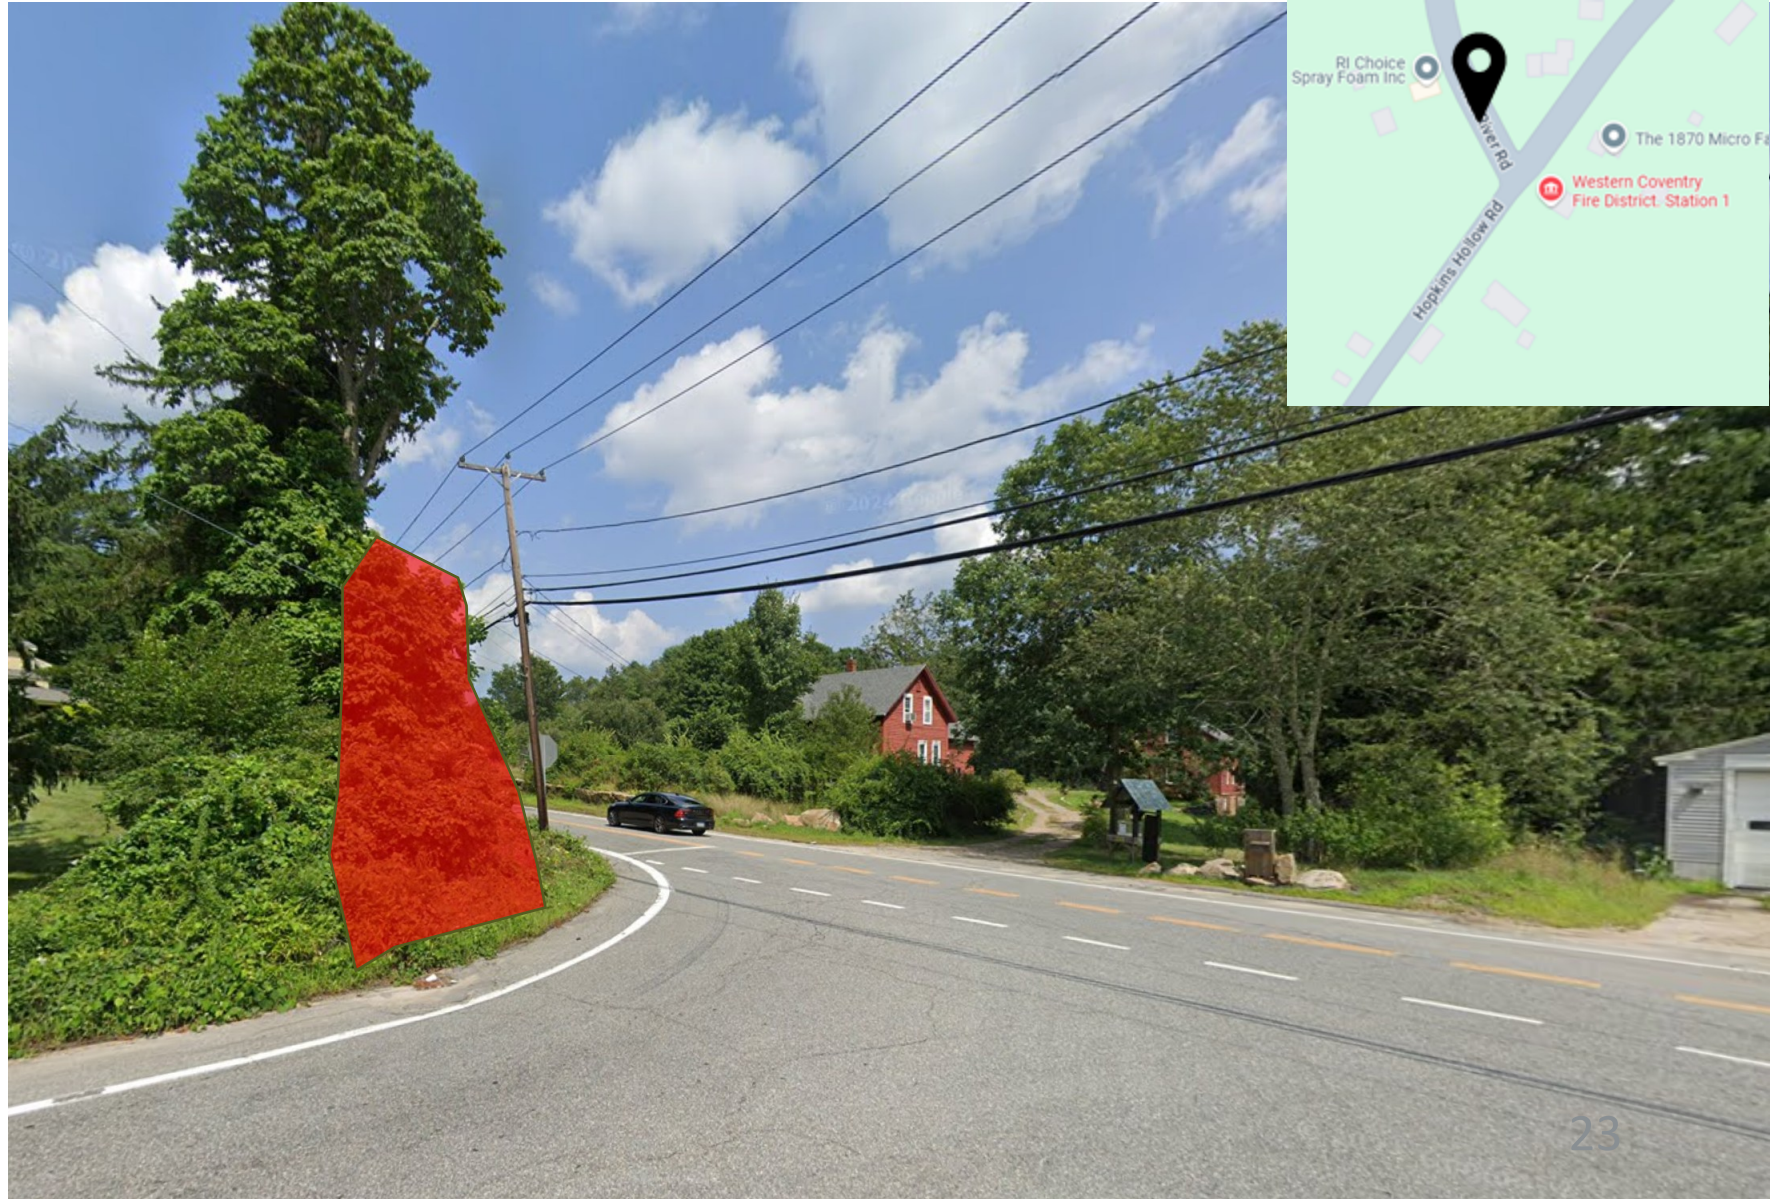
Lighting

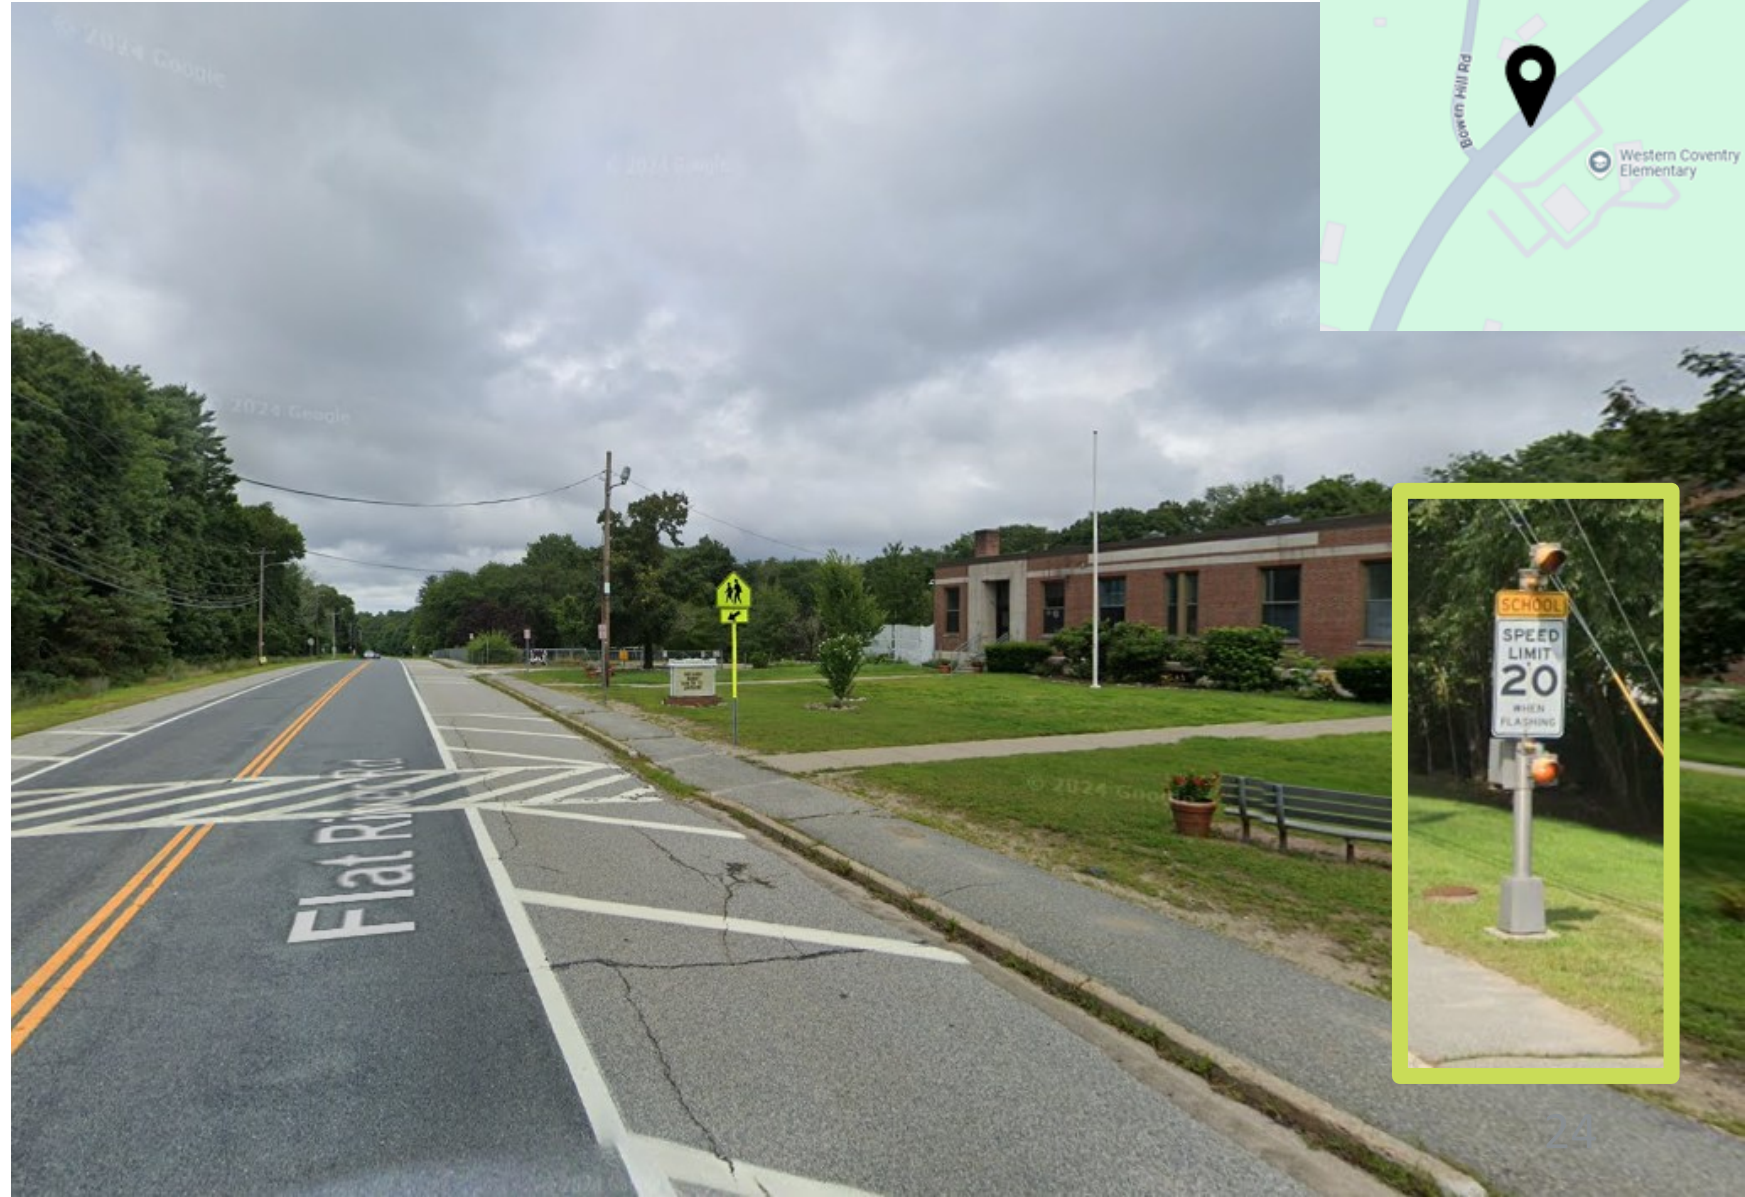
- More rural roadway, conducive to higher speeds
- School zone is well marked with flashers on both approaches
- At pick up time vehicles parked in both shoulders waiting for students

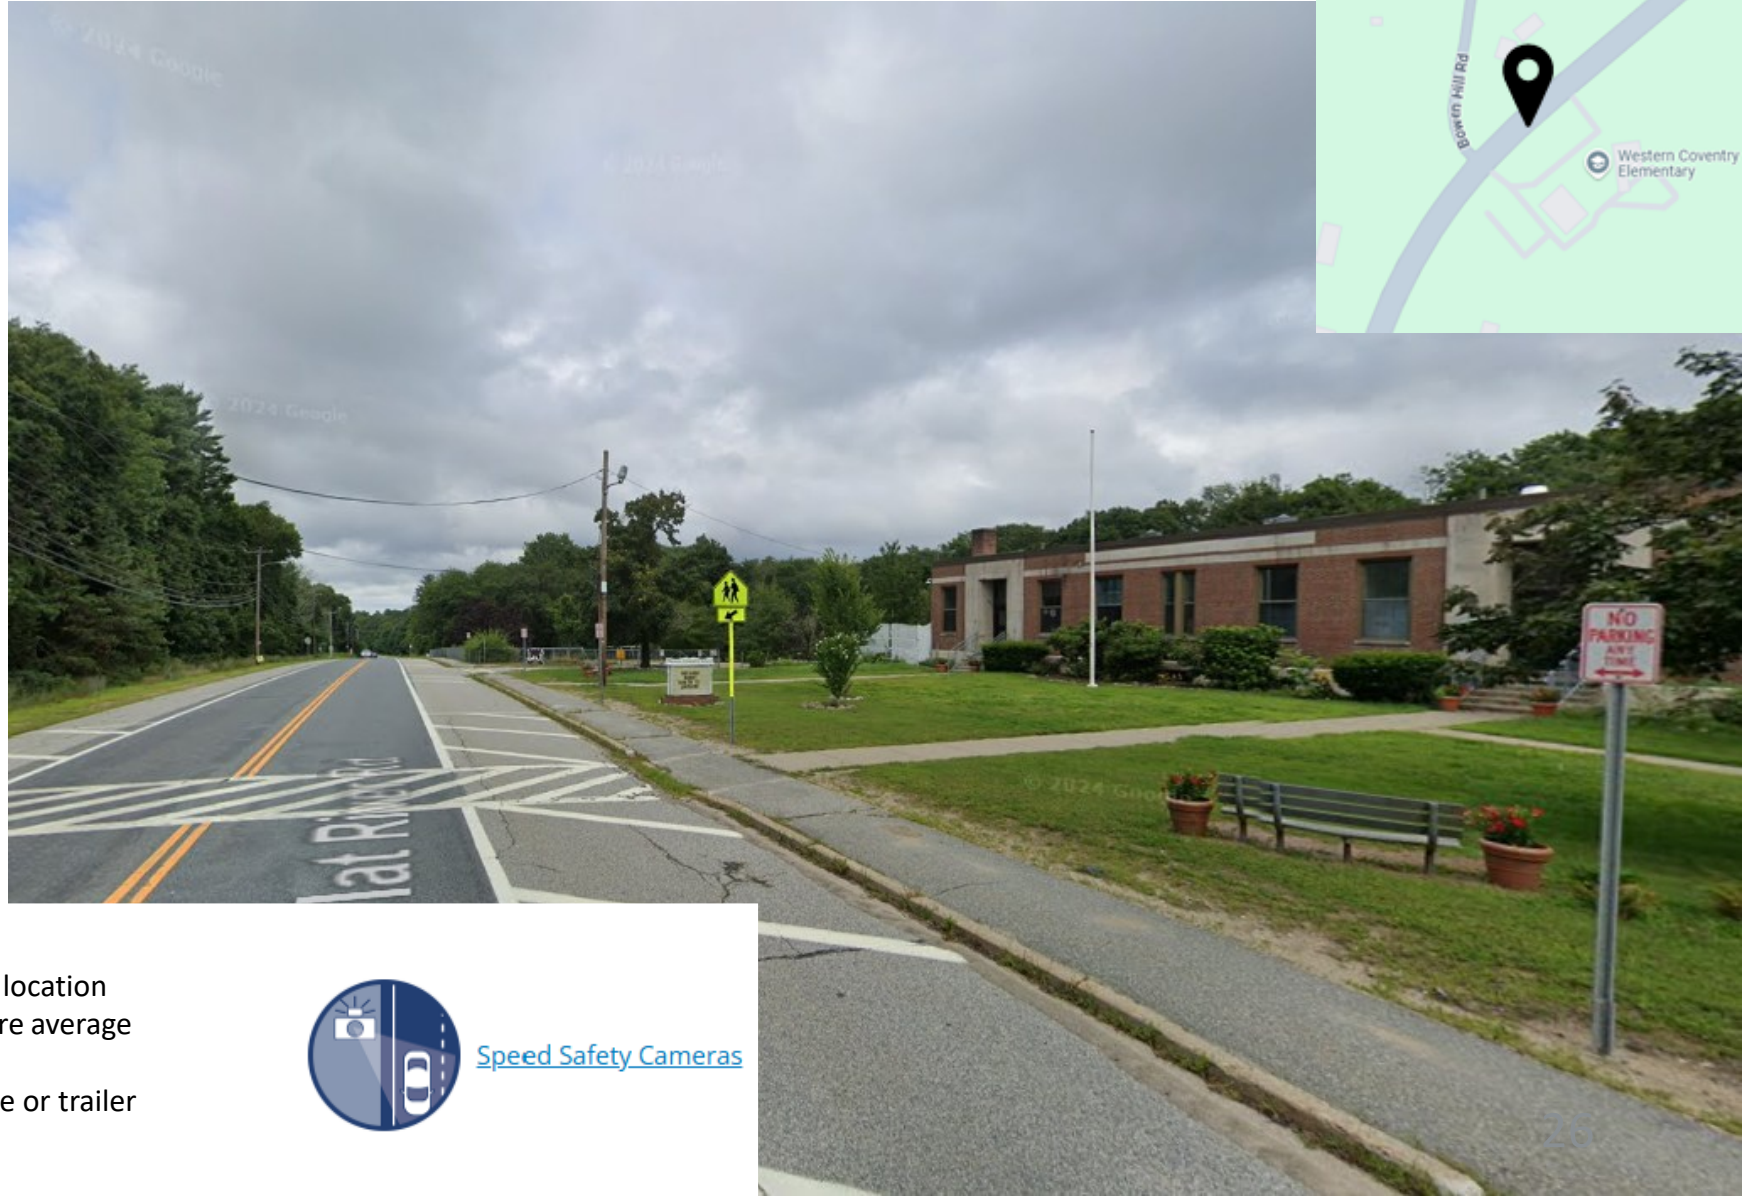
[Speed Safety Cameras](#)

- Consider the use of Speed Safety Cameras (SSC) in this location given it is regulated school zone and speeding has been reported as an issue.
- SSCs detect speeding and capture photographic evidence of vehicles that are violating a set speed threshold.
- Public outreach is essential, and equity impacts need to be considered

SSCs can be deployed as:

- **Fixed units** – a single, stationary camera targeting one location
- **Point to Point (P2P) units** – multiple cameras to capture average speed over a certain distance
- **Mobile units** – a portable camera, generally in a vehicle or trailer

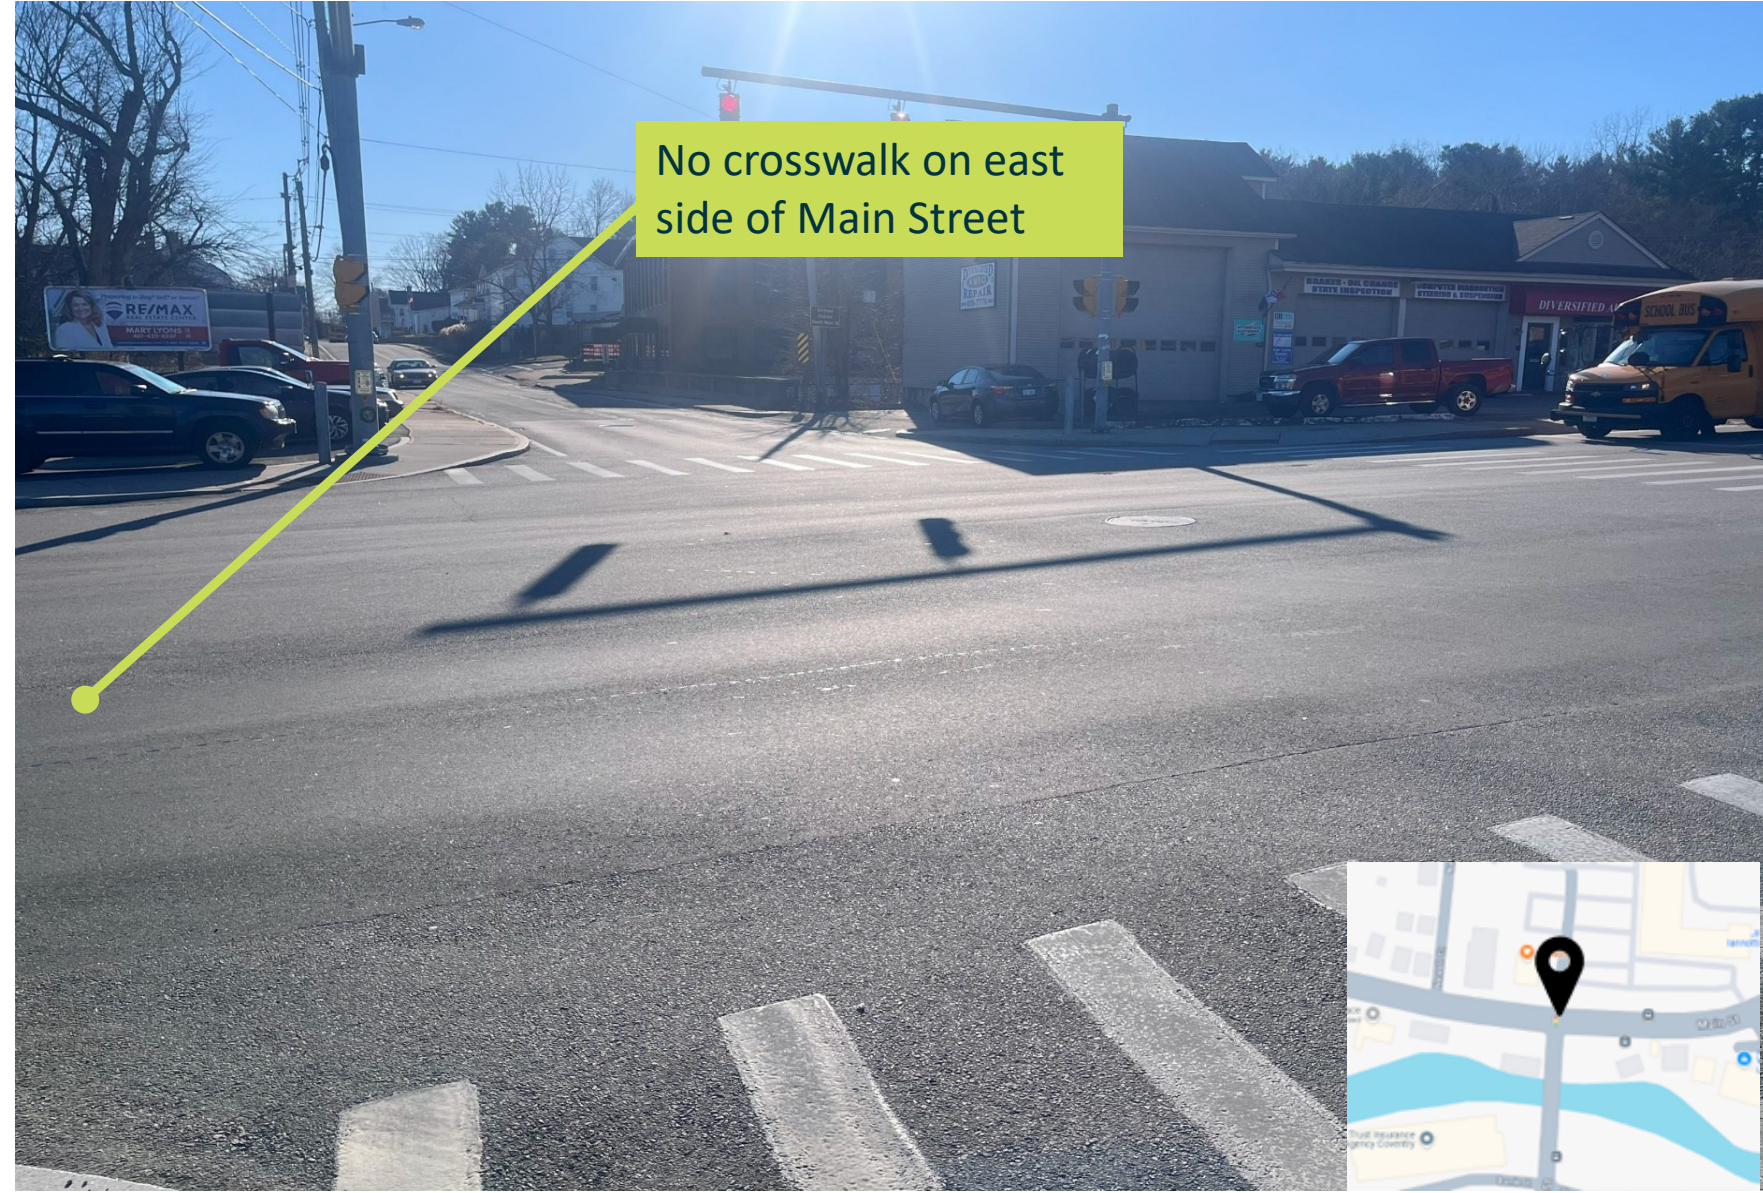
- Congested, signal controlled, 4-way intersection
- **Crosswalks on 3 crossings**
- Missing pedestrian heads on the driveway entrance
- Turn lanes on Main Street added recently

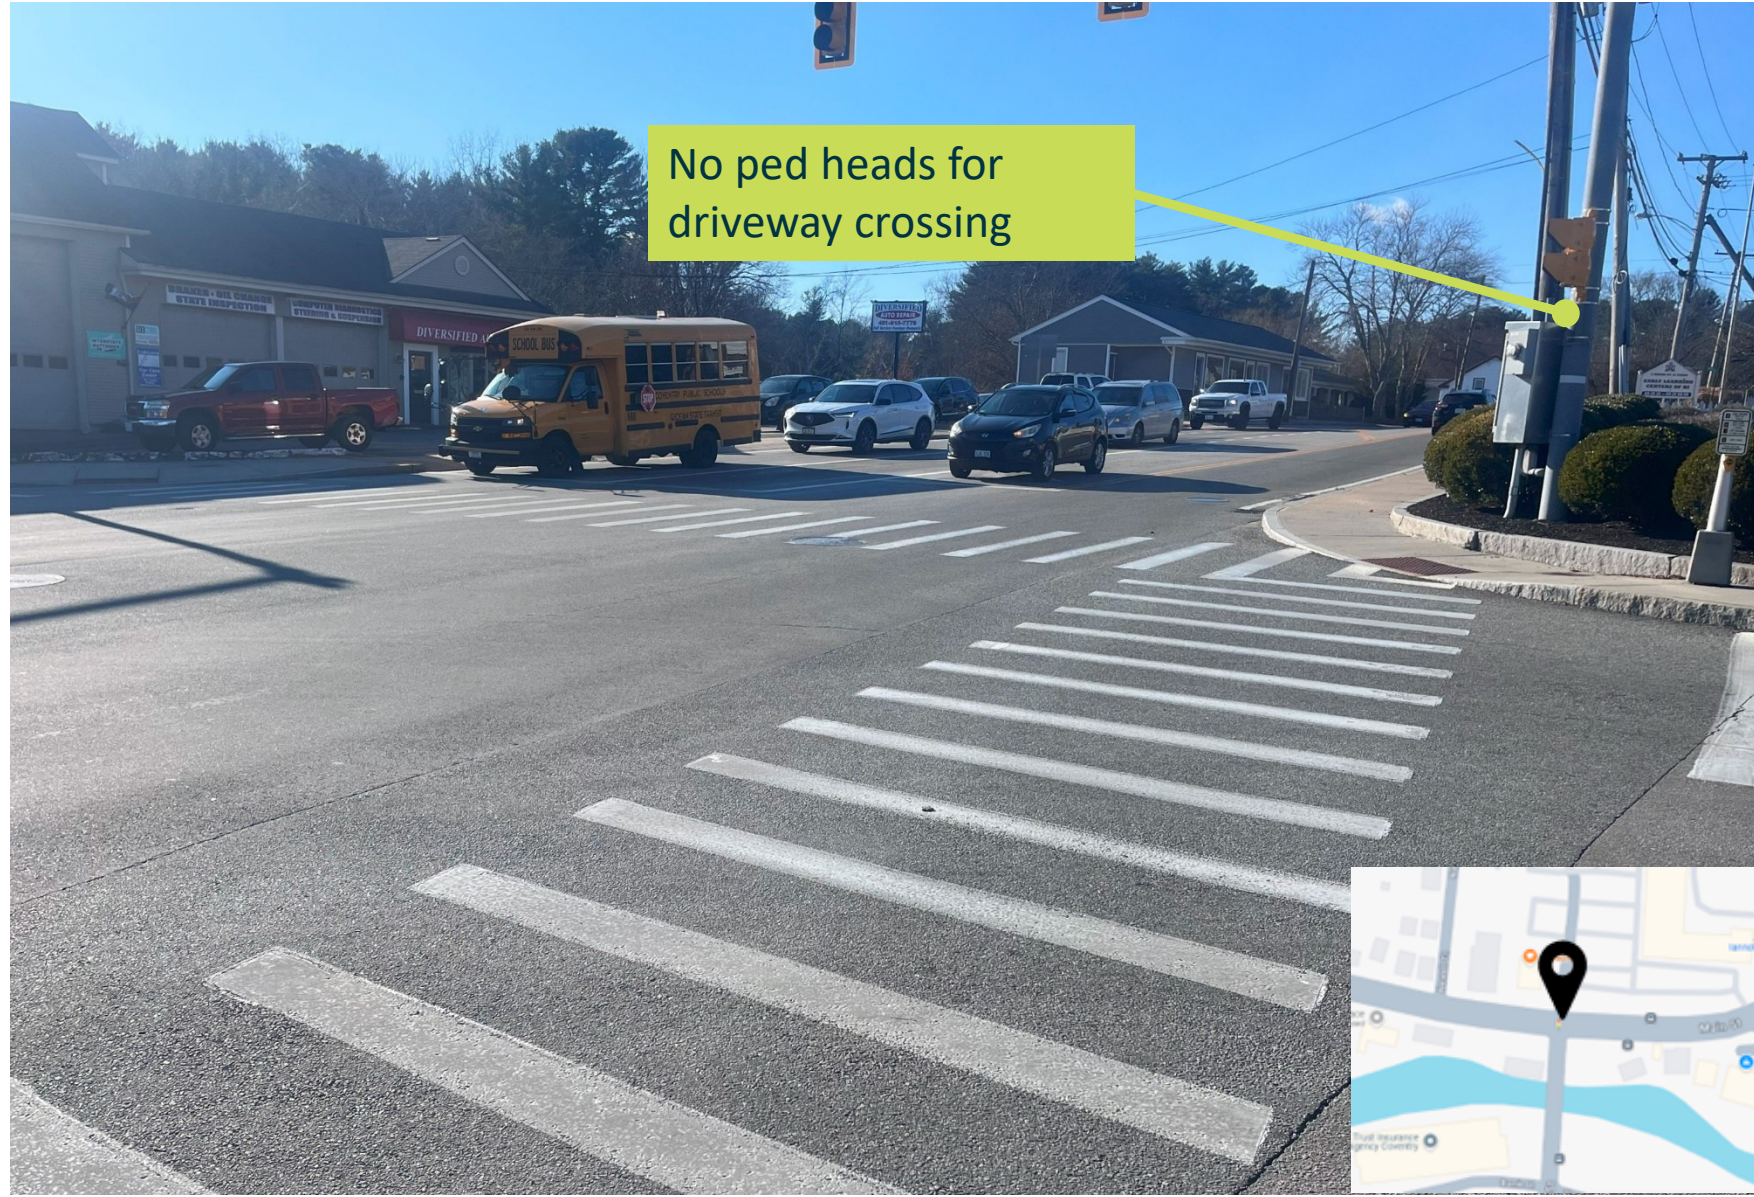
- Congested, signal controlled, 4-way intersection
- Crosswalks on 3 crossings
- **Missing pedestrian heads on the driveway entrance**
- Turn lanes on Main Street added in 2019

- Add pedestrian signal head to driveway crossing
- Add crosswalk to east side of Main Street
- Consider a No Turn on Red from S. Main St NB to Main St EB

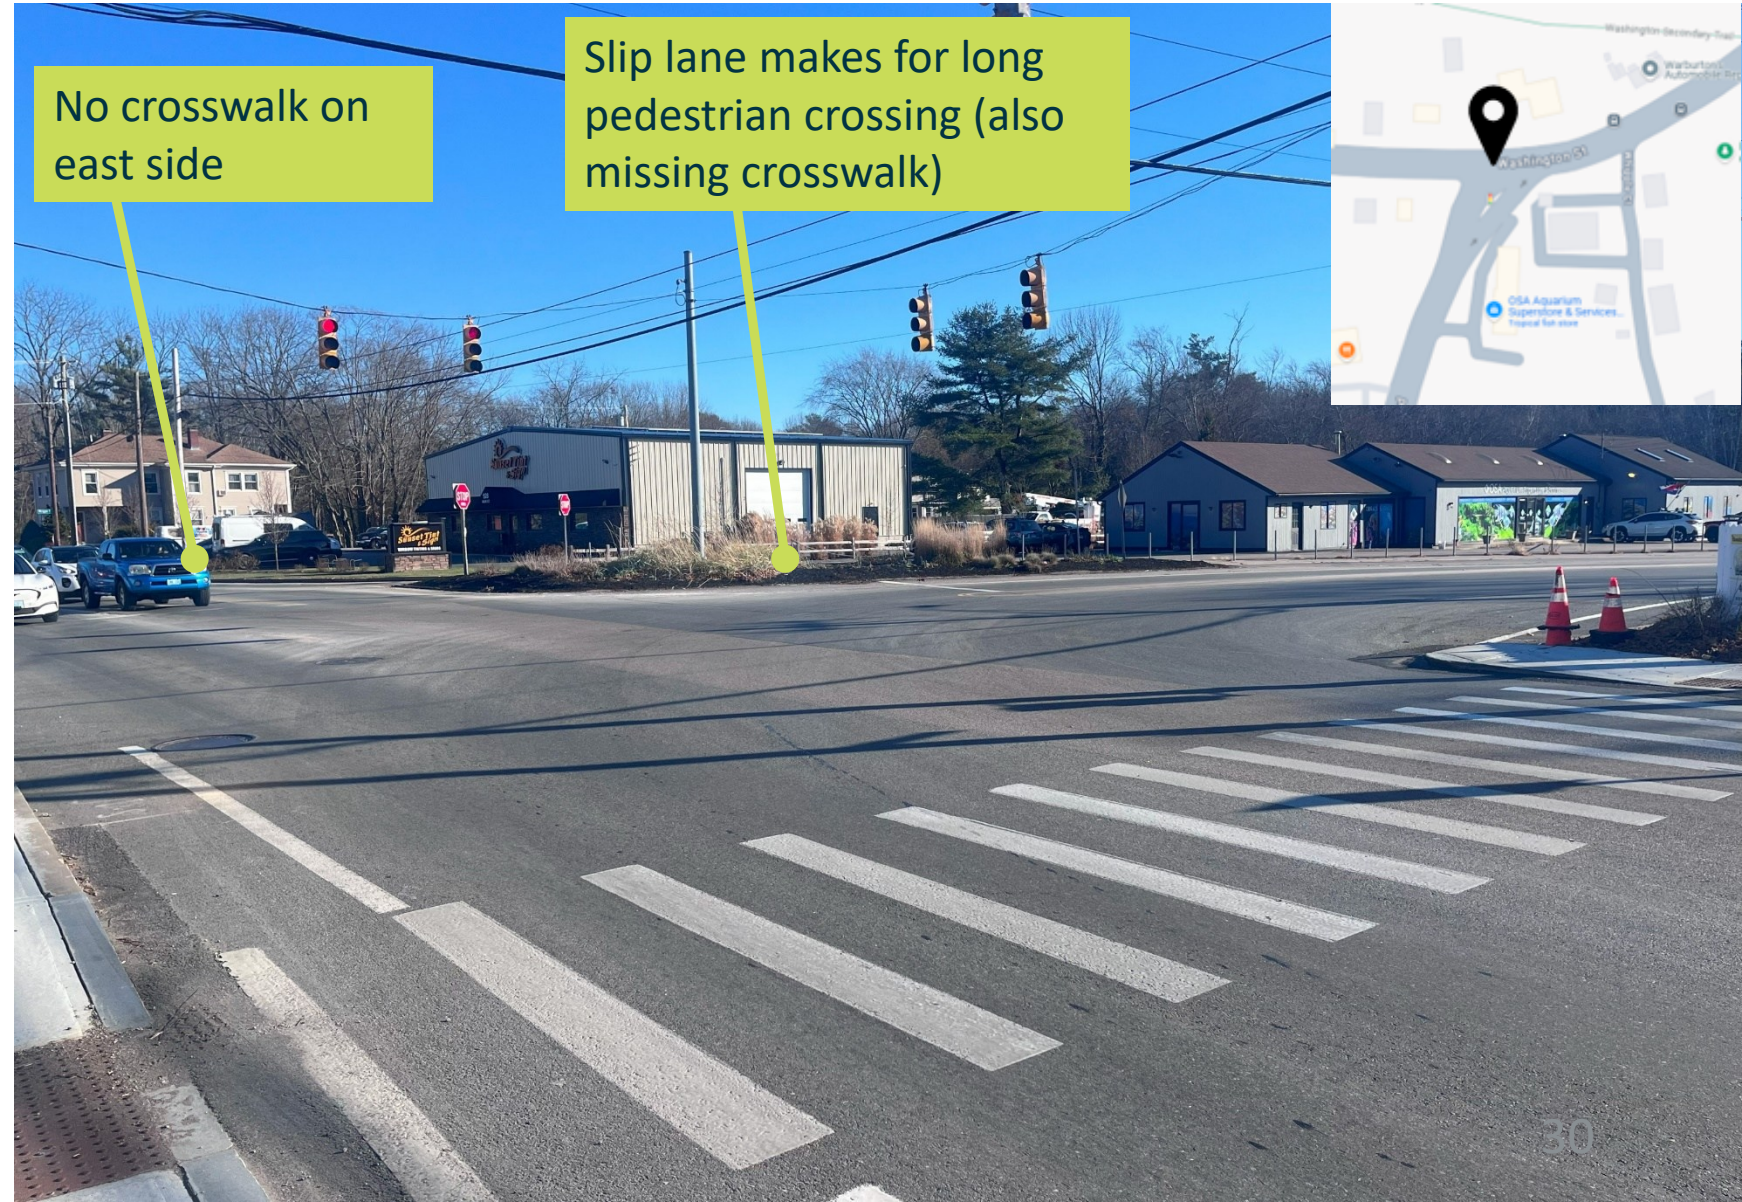
- 3-way intersection with driveway as 4th leg. Signal controlled but slip lane has a stop sign.
- Slip lane for right turns from Sandy Bottom to Washington Street
- One crosswalk at the intersection on west side but most pedestrians are on east side
- Signal heads lack backplates and reflective borders
- Sandy Bottom Road not does have sidewalks

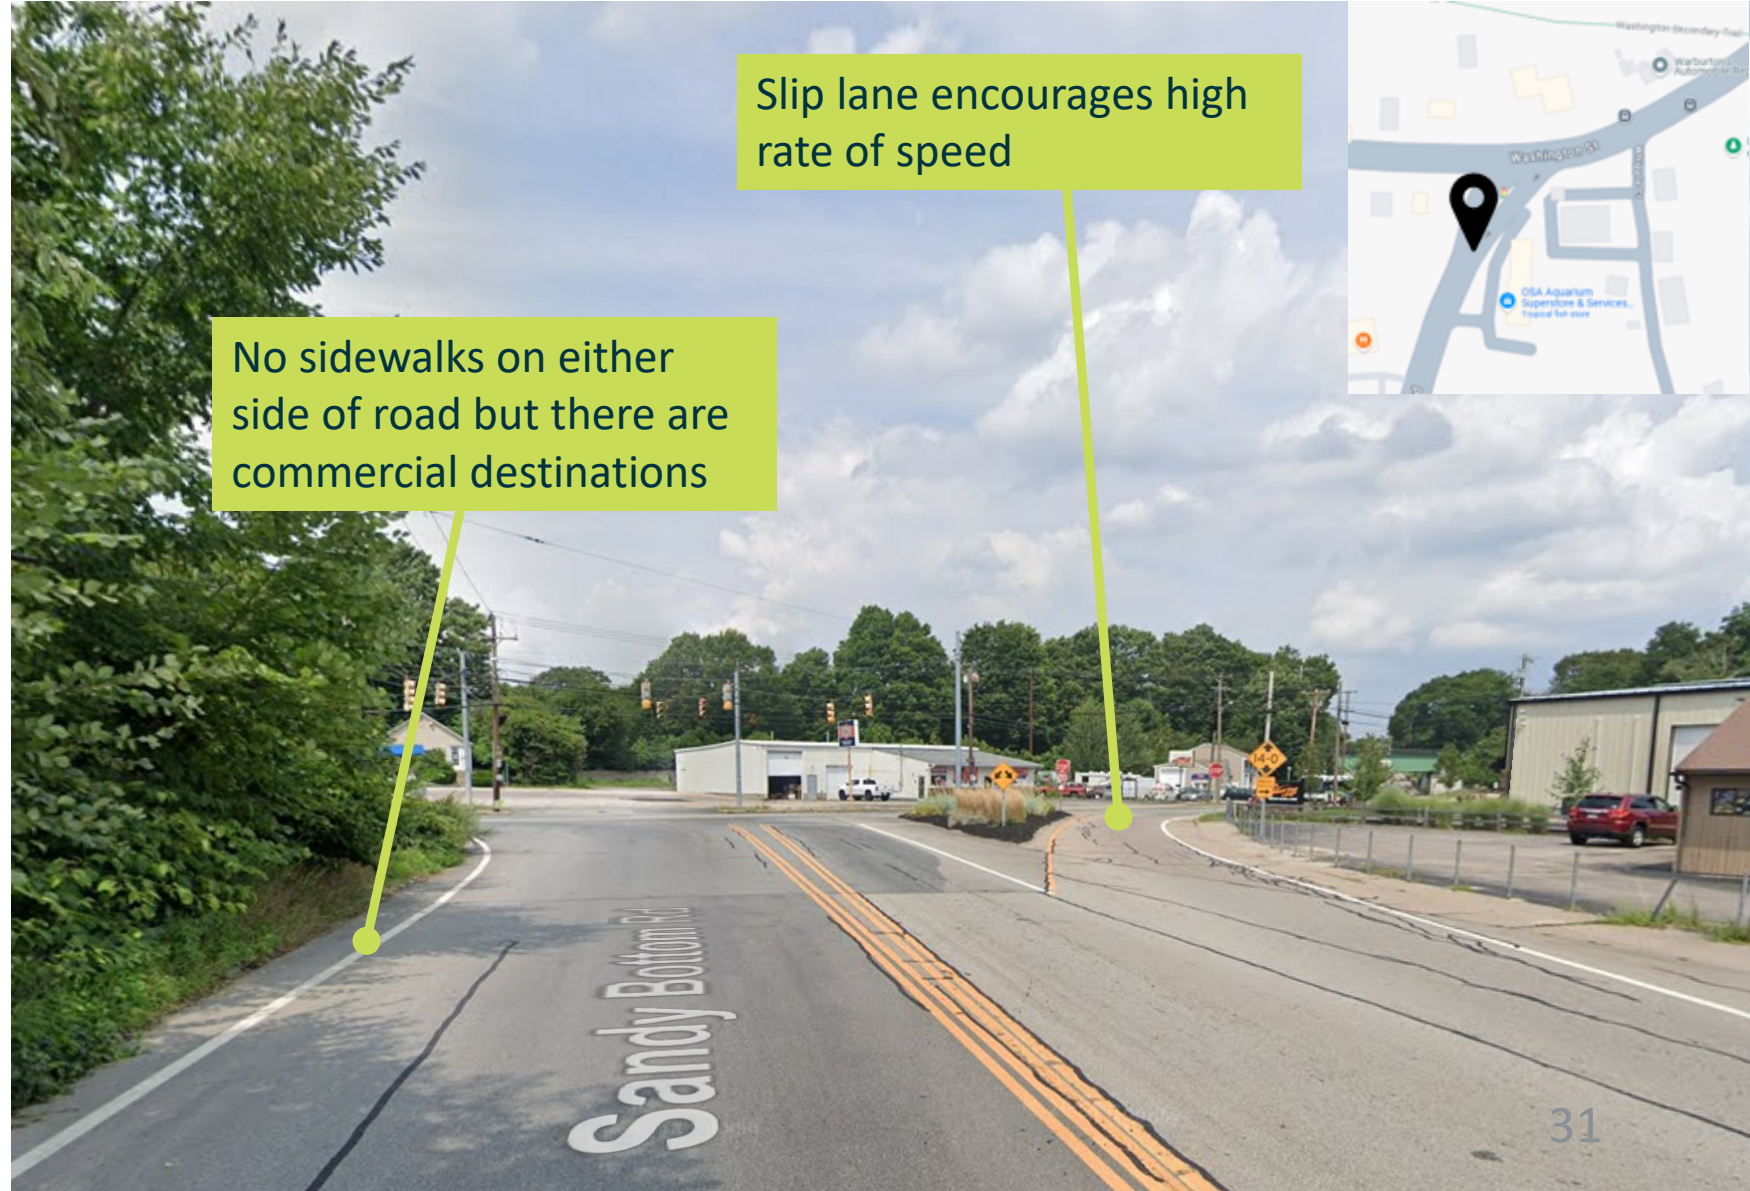
- 3-way intersection with driveway as 4th leg. Signal controlled but slip lane has a stop sign
- **Slip lane for right turns from Sandy Bottom to Washington Street**
- One crosswalk at the intersection on west side but most pedestrians are on east side
- Signal heads lack backplates and reflective borders
- **Sandy Bottom Road does not have sidewalks**

- Add crosswalks across Sandy Bottom Road and west side of Washington Street
- Extend new sidewalks down Sandy Bottom Road
- Advocate for full suite of improvements from TIP Project 5018 on Sandy Bottom Rd (programmed 2027)

- Consider removing slip lane and re-orienting intersection to more traditional T-intersection

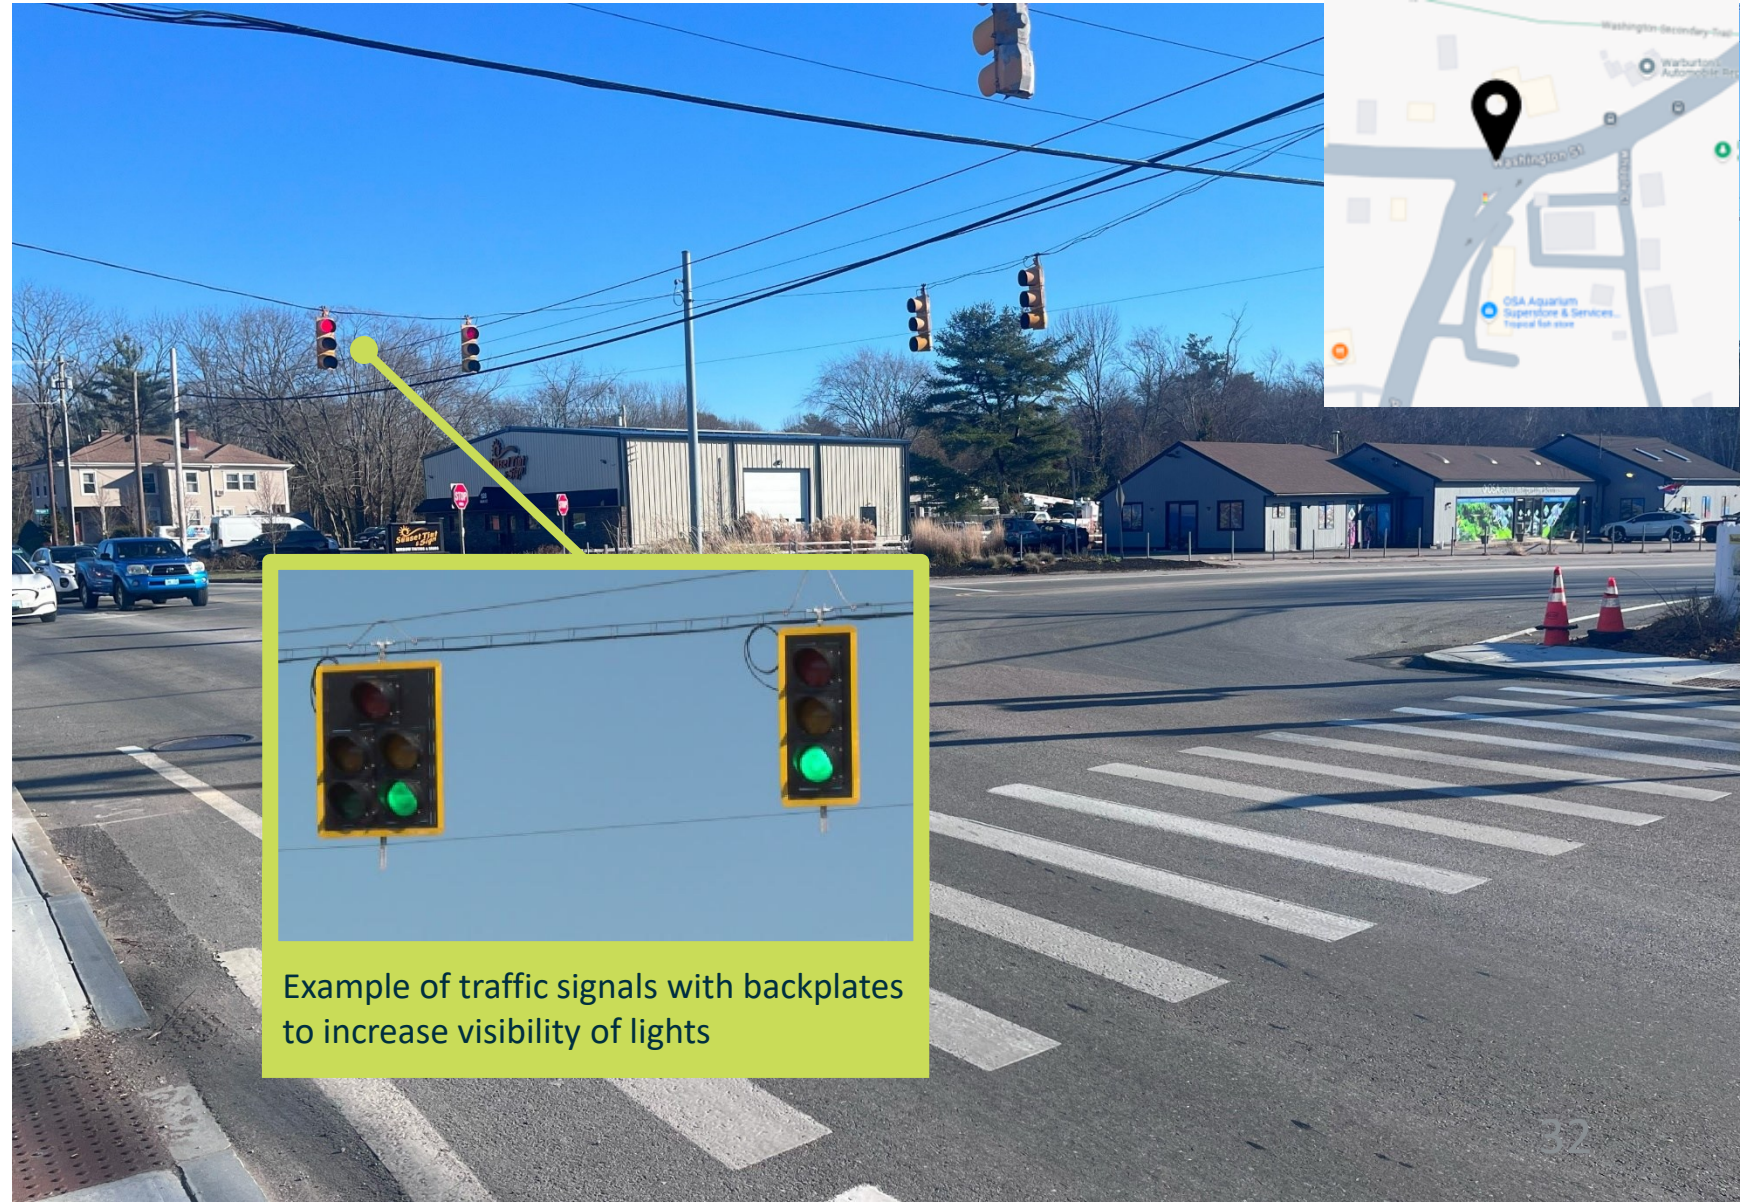
Example of traffic signals with backplates to increase visibility of lights

- **Verify the additional weight of the backplates (including wind and ice loads) would not exceed loading capacity**
- **If able, add backplates to traffic signals**

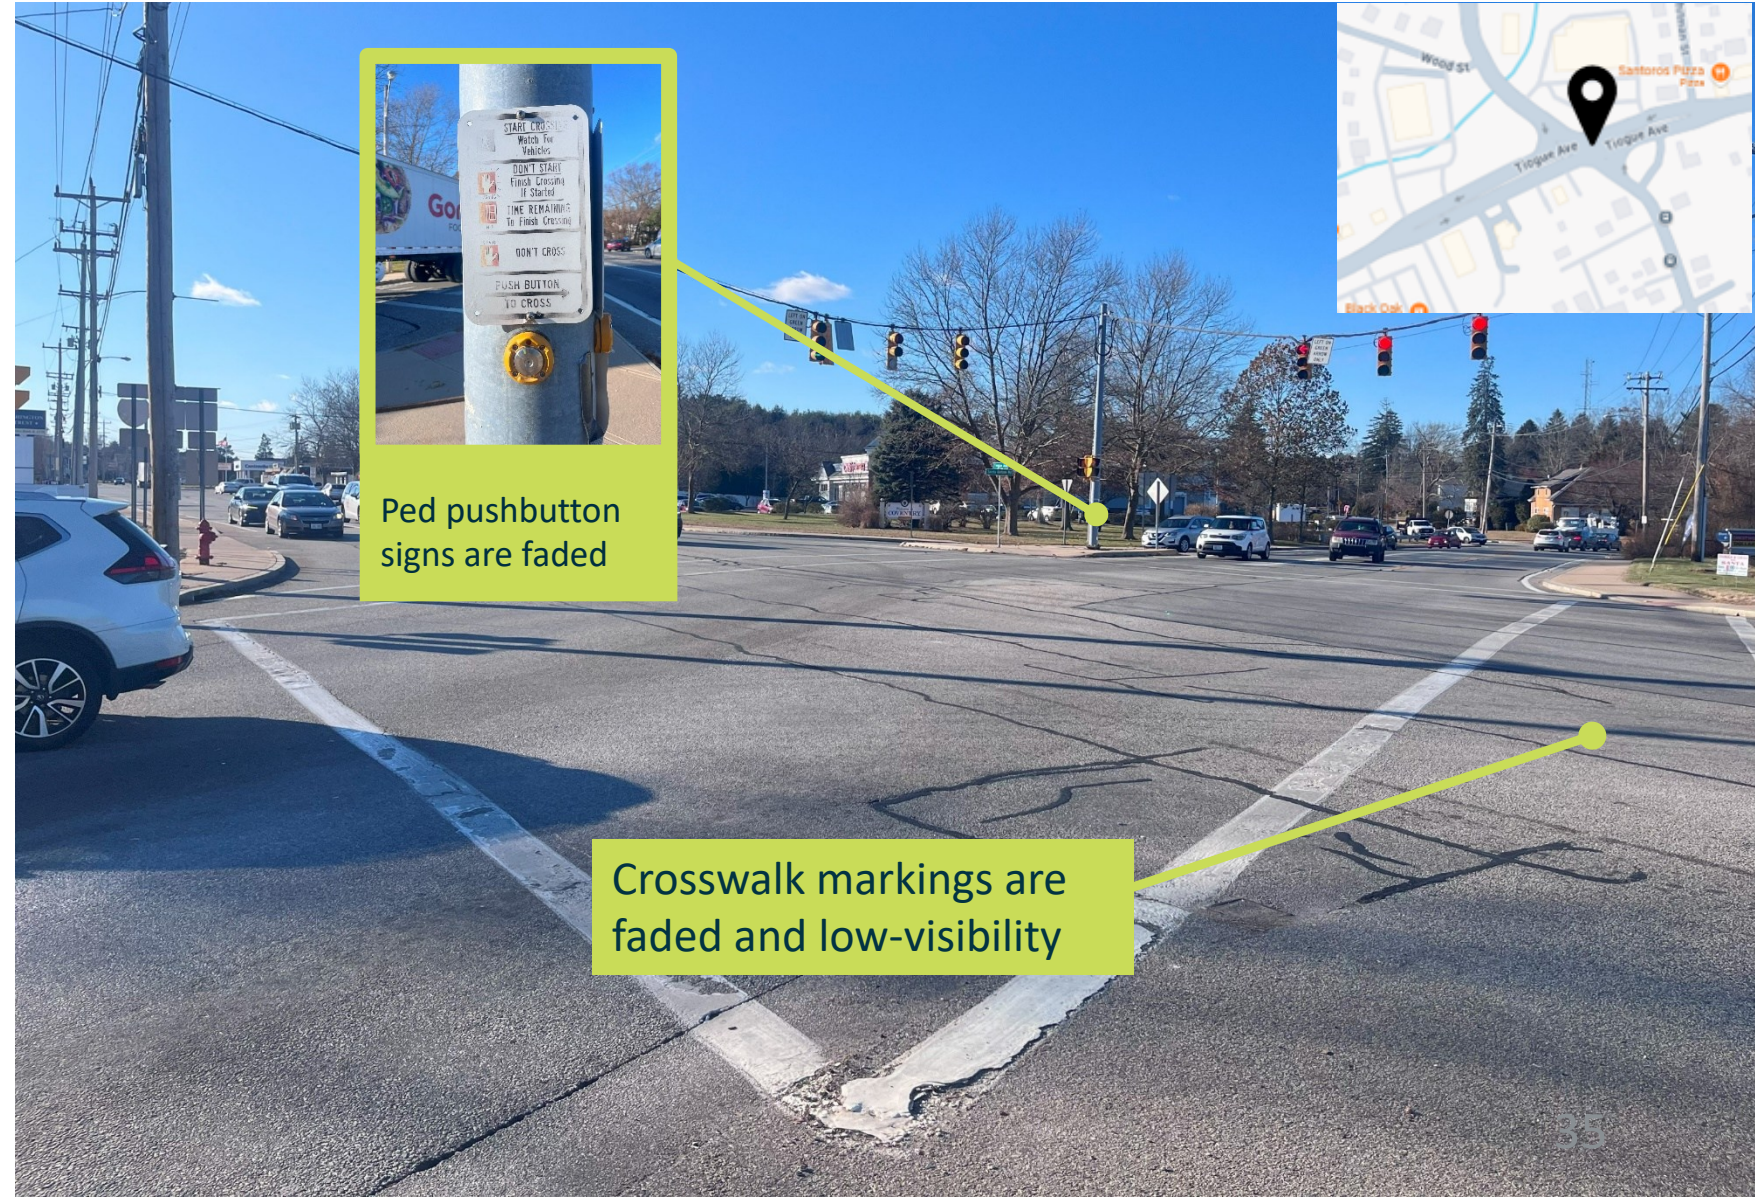
- 4-way signalized intersection; slip lanes under yield-control
- Slip lanes on north and south approaches with unsignalized crosswalks
- **Crosswalks on all 4 crossings but are low visibility**
- Apex ramps (1 button and ramp per corner)
- **Ped pushbuttons are faded**
- Signals without backing plates and reflective borders
- Issues with curb cuts and access management on Tiogue Ave

Ped pushbutton signs are faded

Crosswalk markings are faded and low-visibility

- Repaint crosswalks using continental markings for increased visibility
- Replace faded ped request buttons and signs
- Add backing plates to traffic signals
