Arnold Road, New London Turnpike, and Centre of New England Boulevard

E Flat River Road at Plainfield Pike

Western Coventry Elementary

H Main St and South Main St – Dave's Marketplace

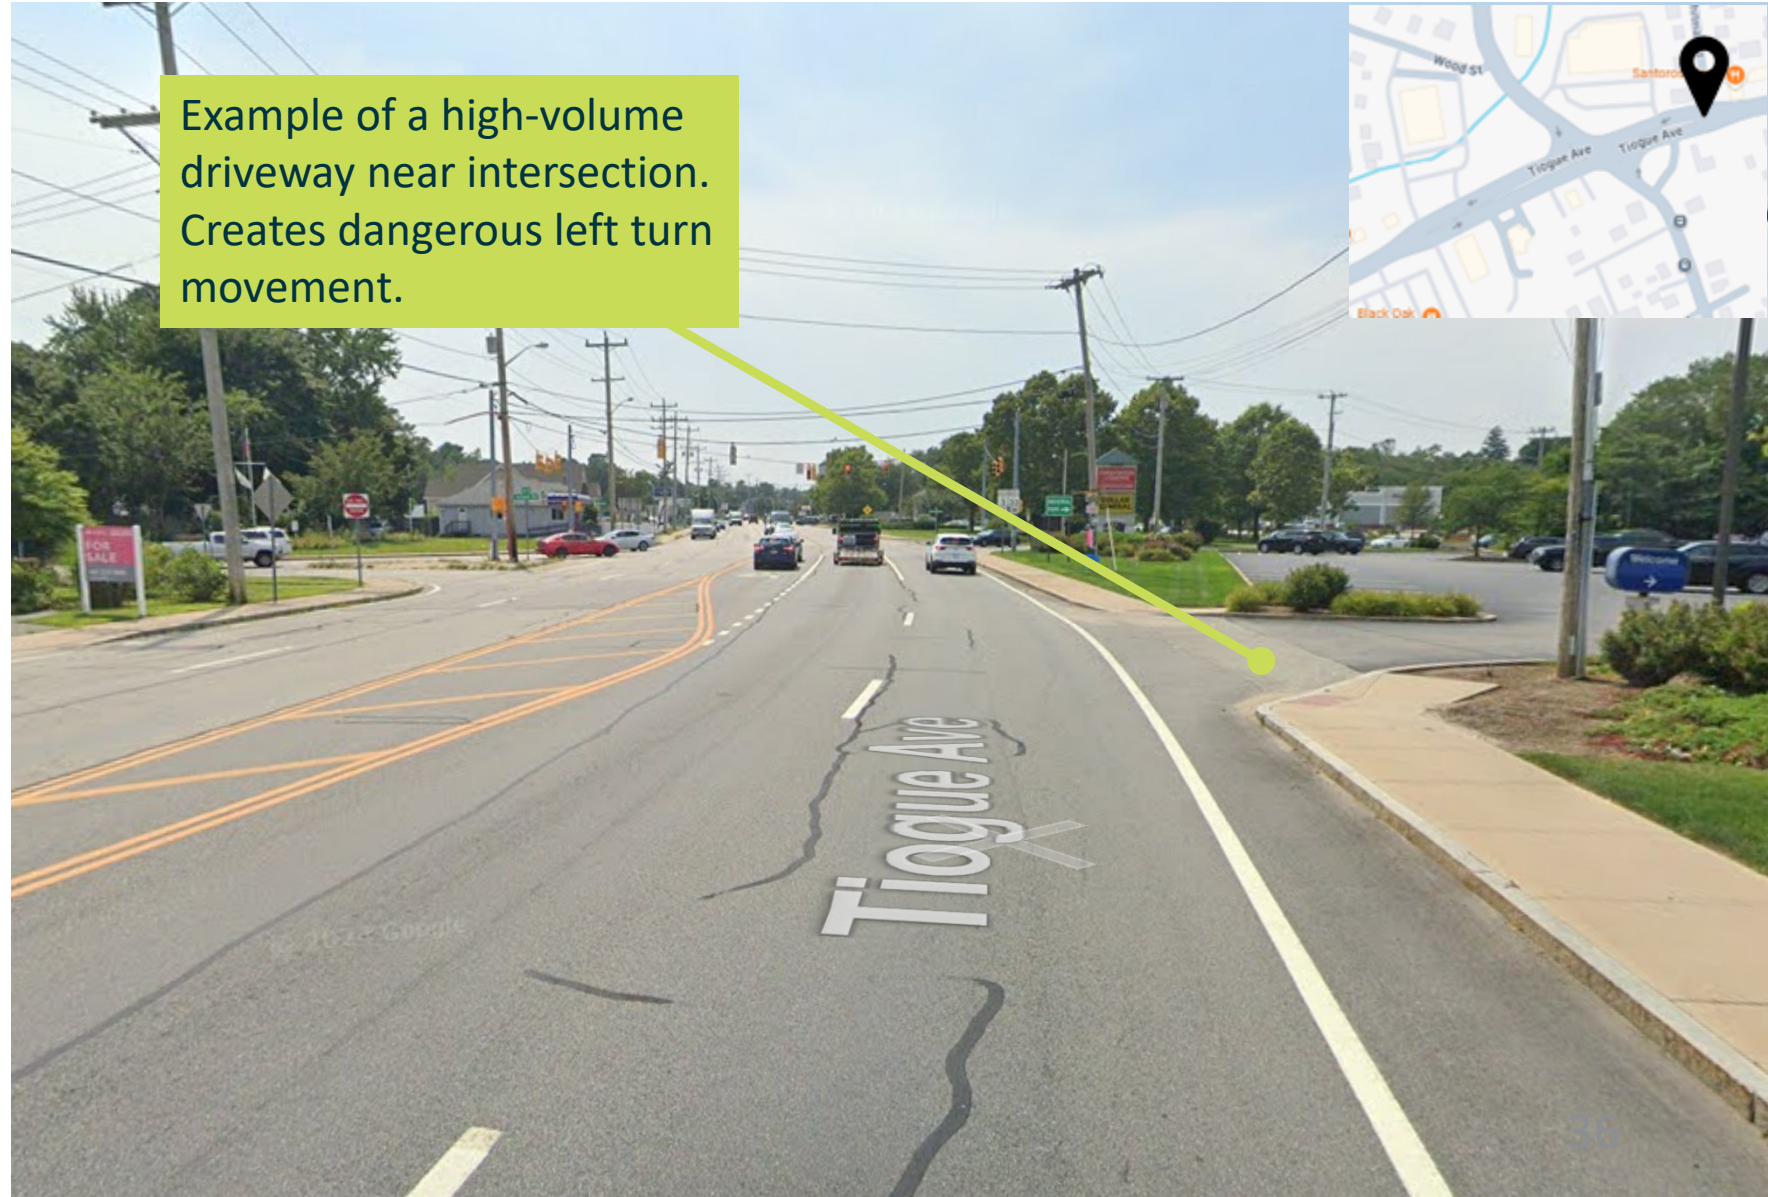
- 4-way signalized intersection; slip lanes under yield-control
- Slip lanes on north and south approaches with unsignalized crosswalks
- Crosswalks on all 4 crossings but are low visibility
- Apex ramps (1 button and ramp per corner)
- Ped pushbuttons are faded
- Signals without backing plates and reflective borders
- **Issues with curb cuts and access management on Tiogue Ave**

Example of a high-volume driveway near intersection. Creates dangerous left turn movement.

- Evaluate the necessity and functioning of each driveway adjacent to intersection and consider closing or combining certain driveways or adjusting to right-in/right-out only.

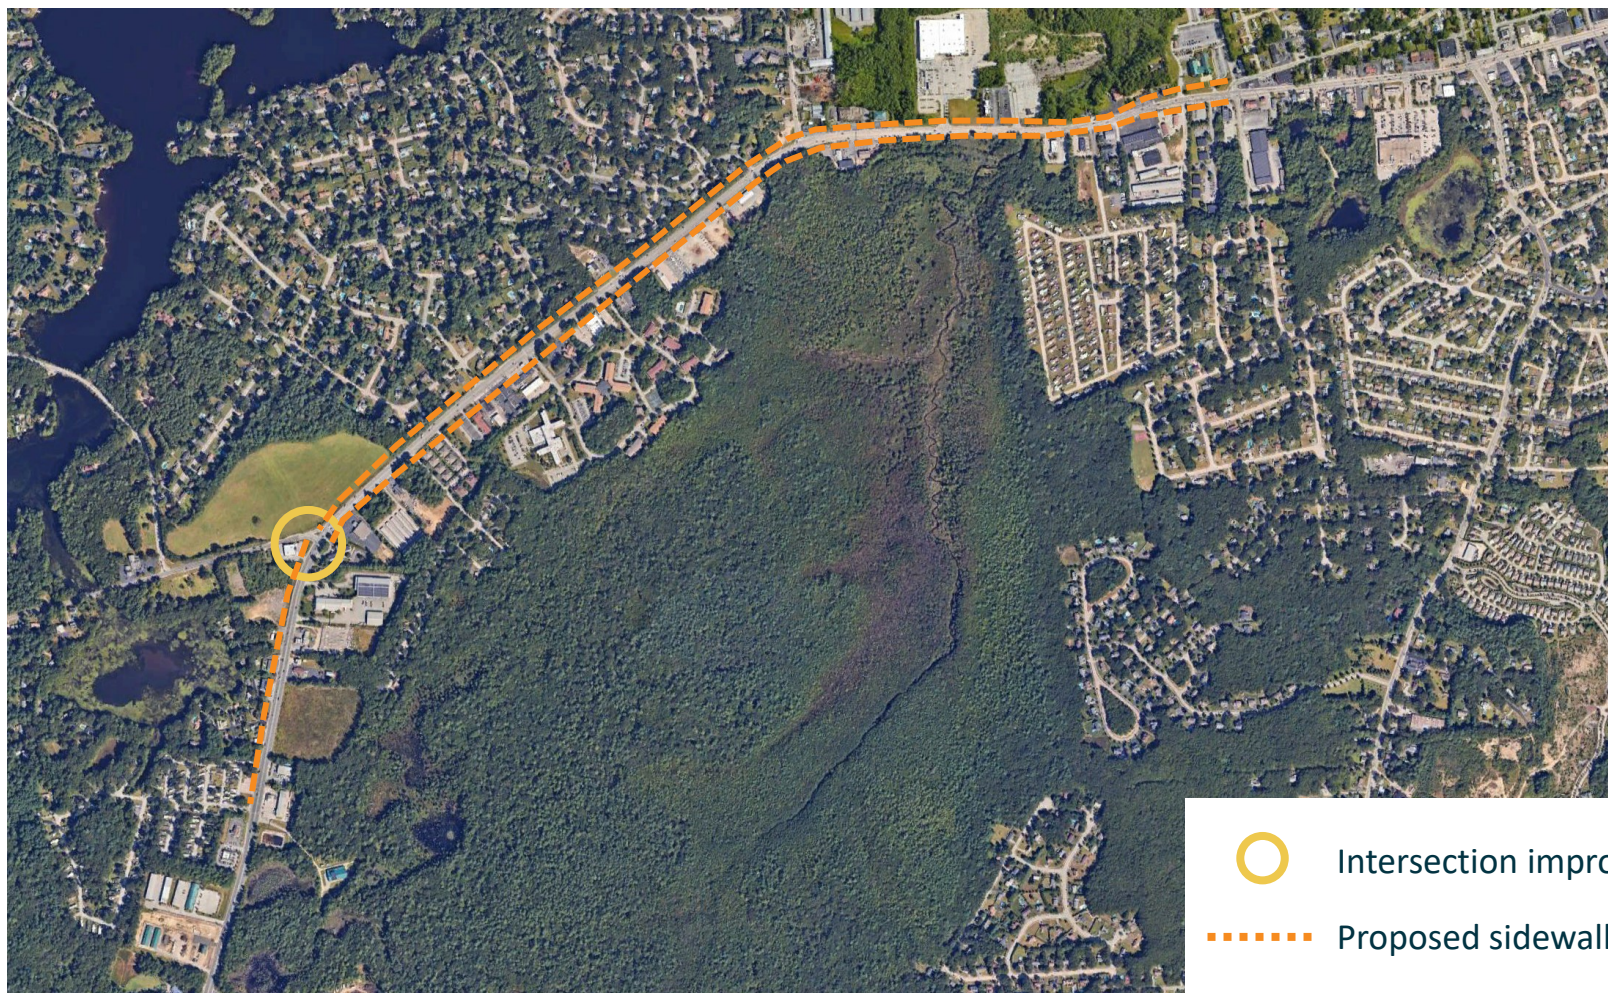
Intersection improvements

Proposed sidewalk

- Construct roughly 2 miles of new sidewalk along Tiogue Avenue/ Nooseneck Hill Road from South Main Street to Linda Drive. Sidewalk should be on both sides of the road for 1.5 miles from South Main Street to Harkney Hill Road but may continue from there southwards on the west side only 2000' to Linda Drive.
