WETLAND REPORT

SITE LOCATION:
A.P. 321, Lot 52
350 Tillinghast Road
Coventry, Rhode Island

PREPARED (August 6, 2025) BY:

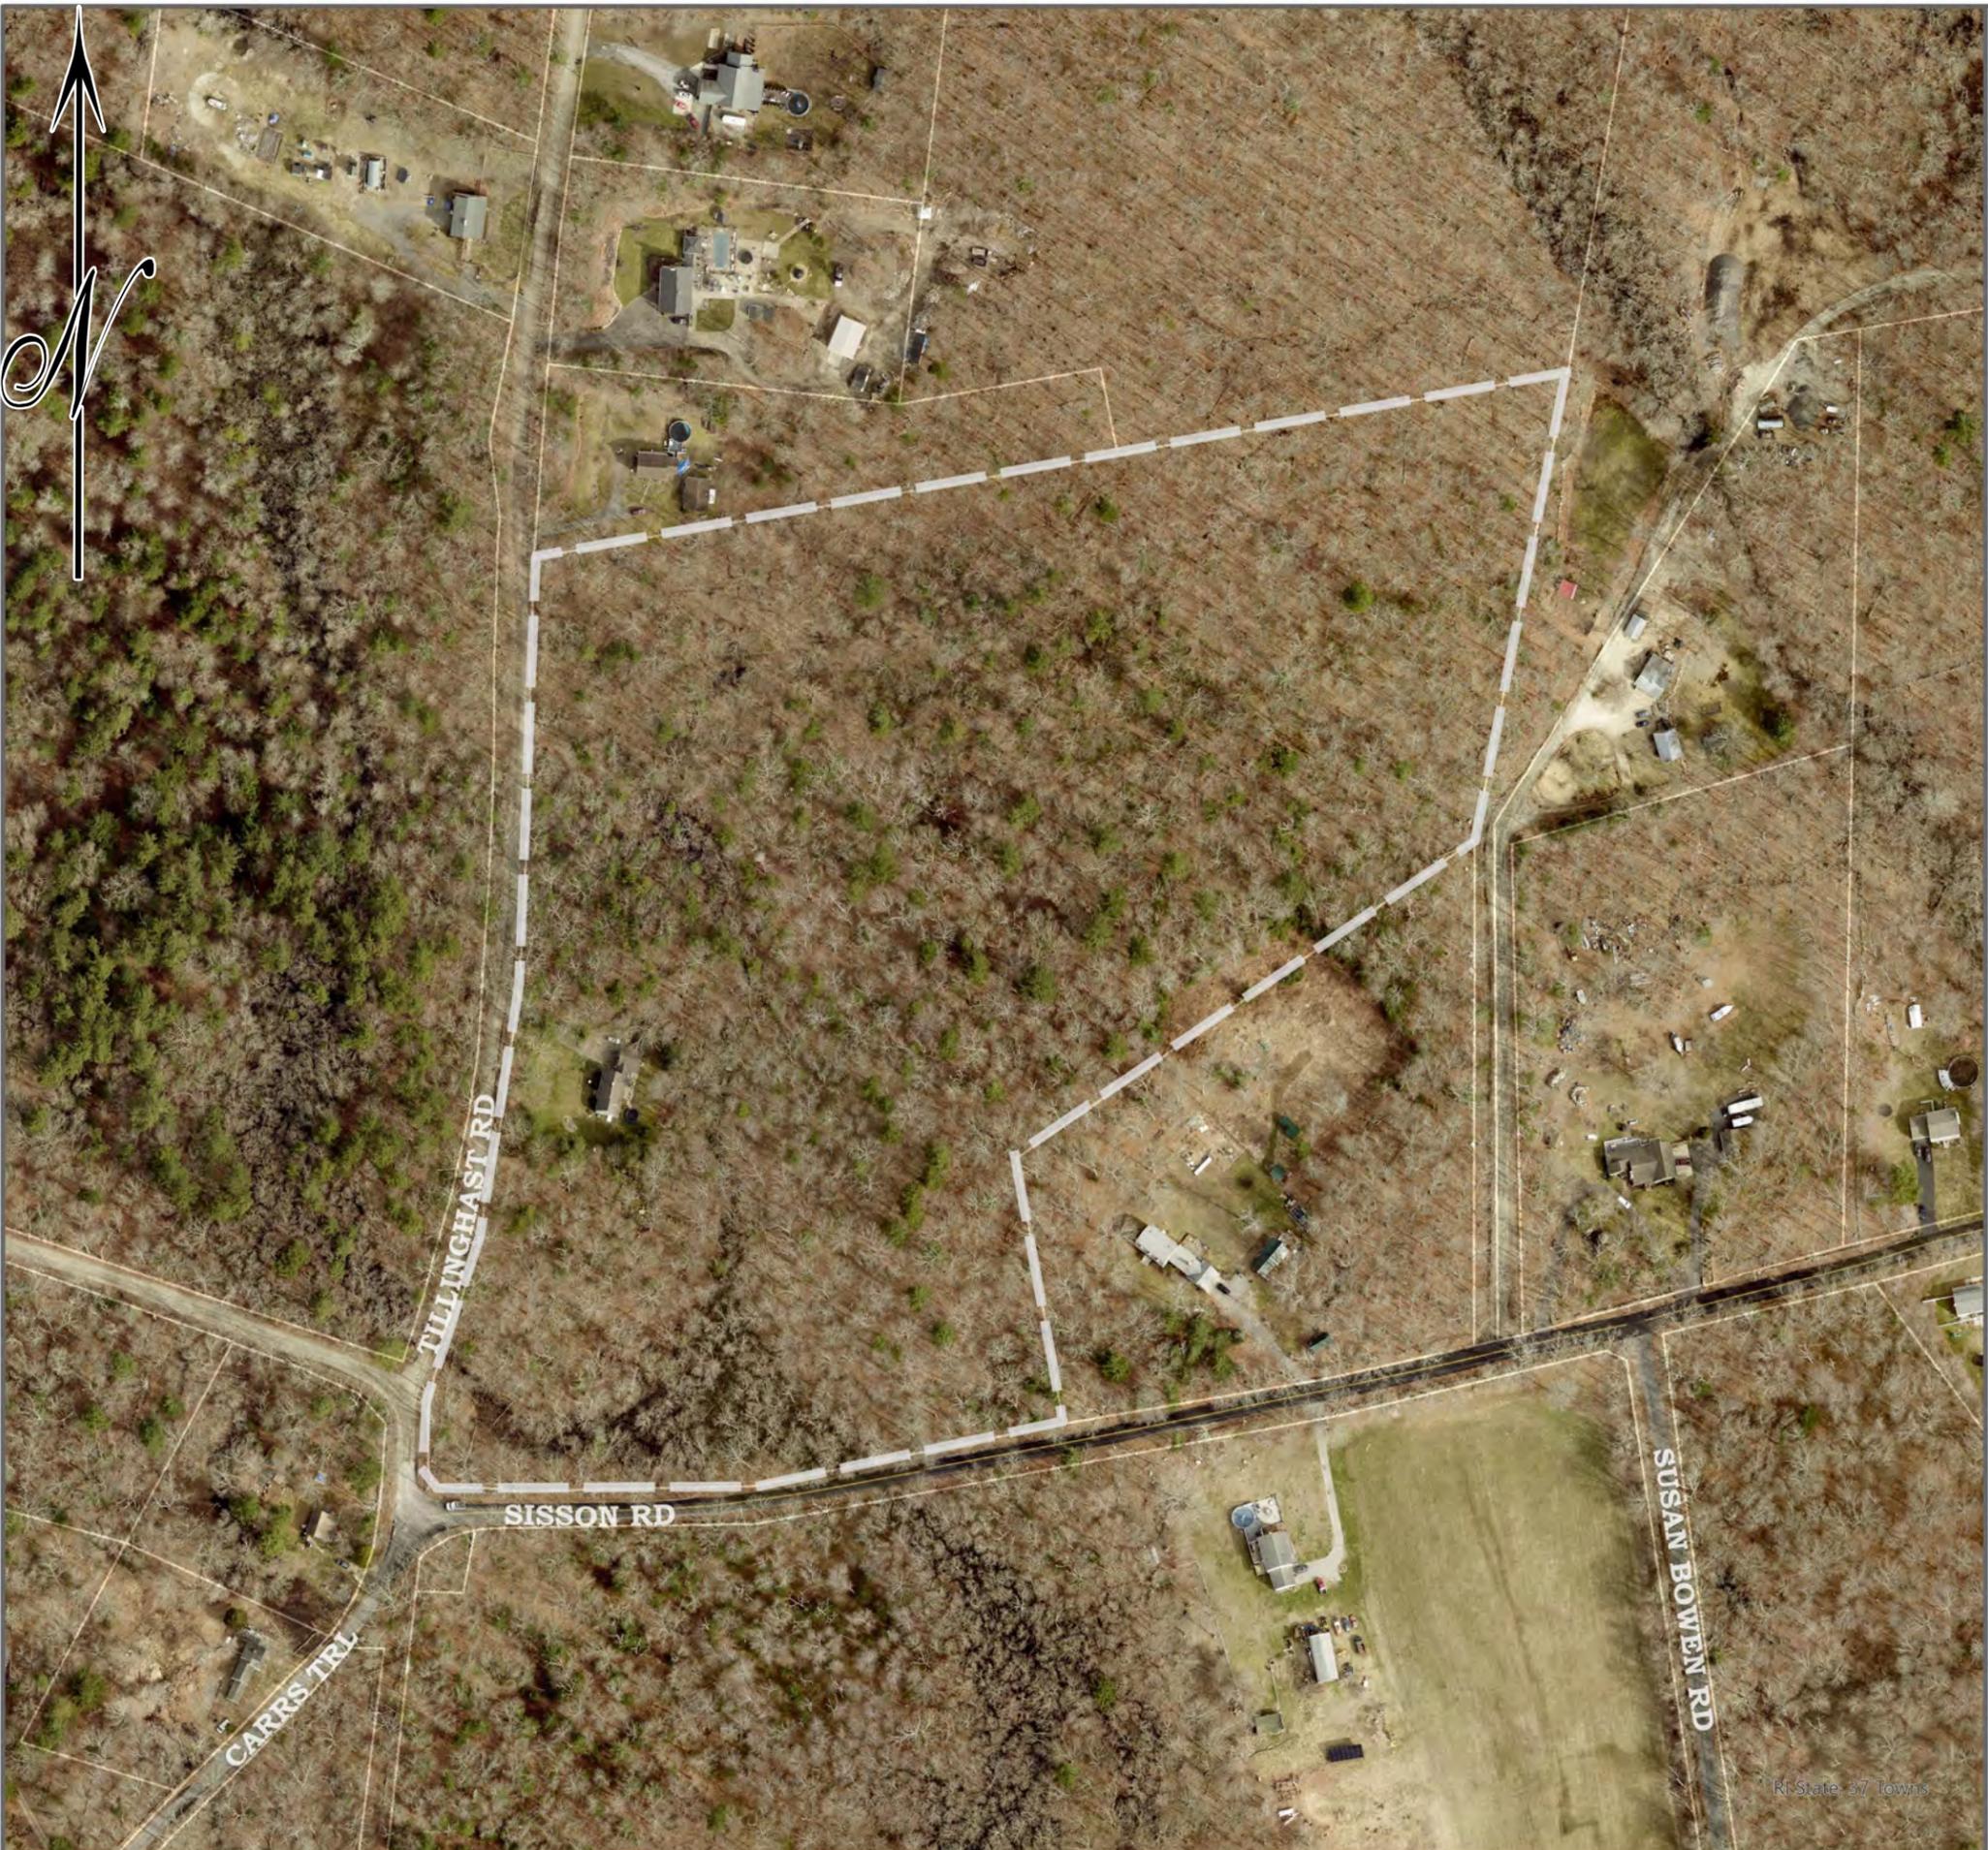
2024 AERIAL MAP
A.P. 321, Lot 52 | 350 Tillinghast Road
Coventry, Rhode Island

The property extends east from Tillinghast Road along Sisson Road in Coventry, Rhode Island. The lot is developed with a residence with an associated driveway and yard near the southwest corner while the majority of the lot remains primarily forested. All limits of wetland impacting the property have been delineated by AES.

A review of historical aerial photographs available from the DEM Environmental Resource Maps shows that, as of the earliest available photographs taken in 1939, this property was undeveloped and primarily forested. The first sign of development can be seen on the imagery from 1981, and the house is finished by the time of the imagery from 1988.

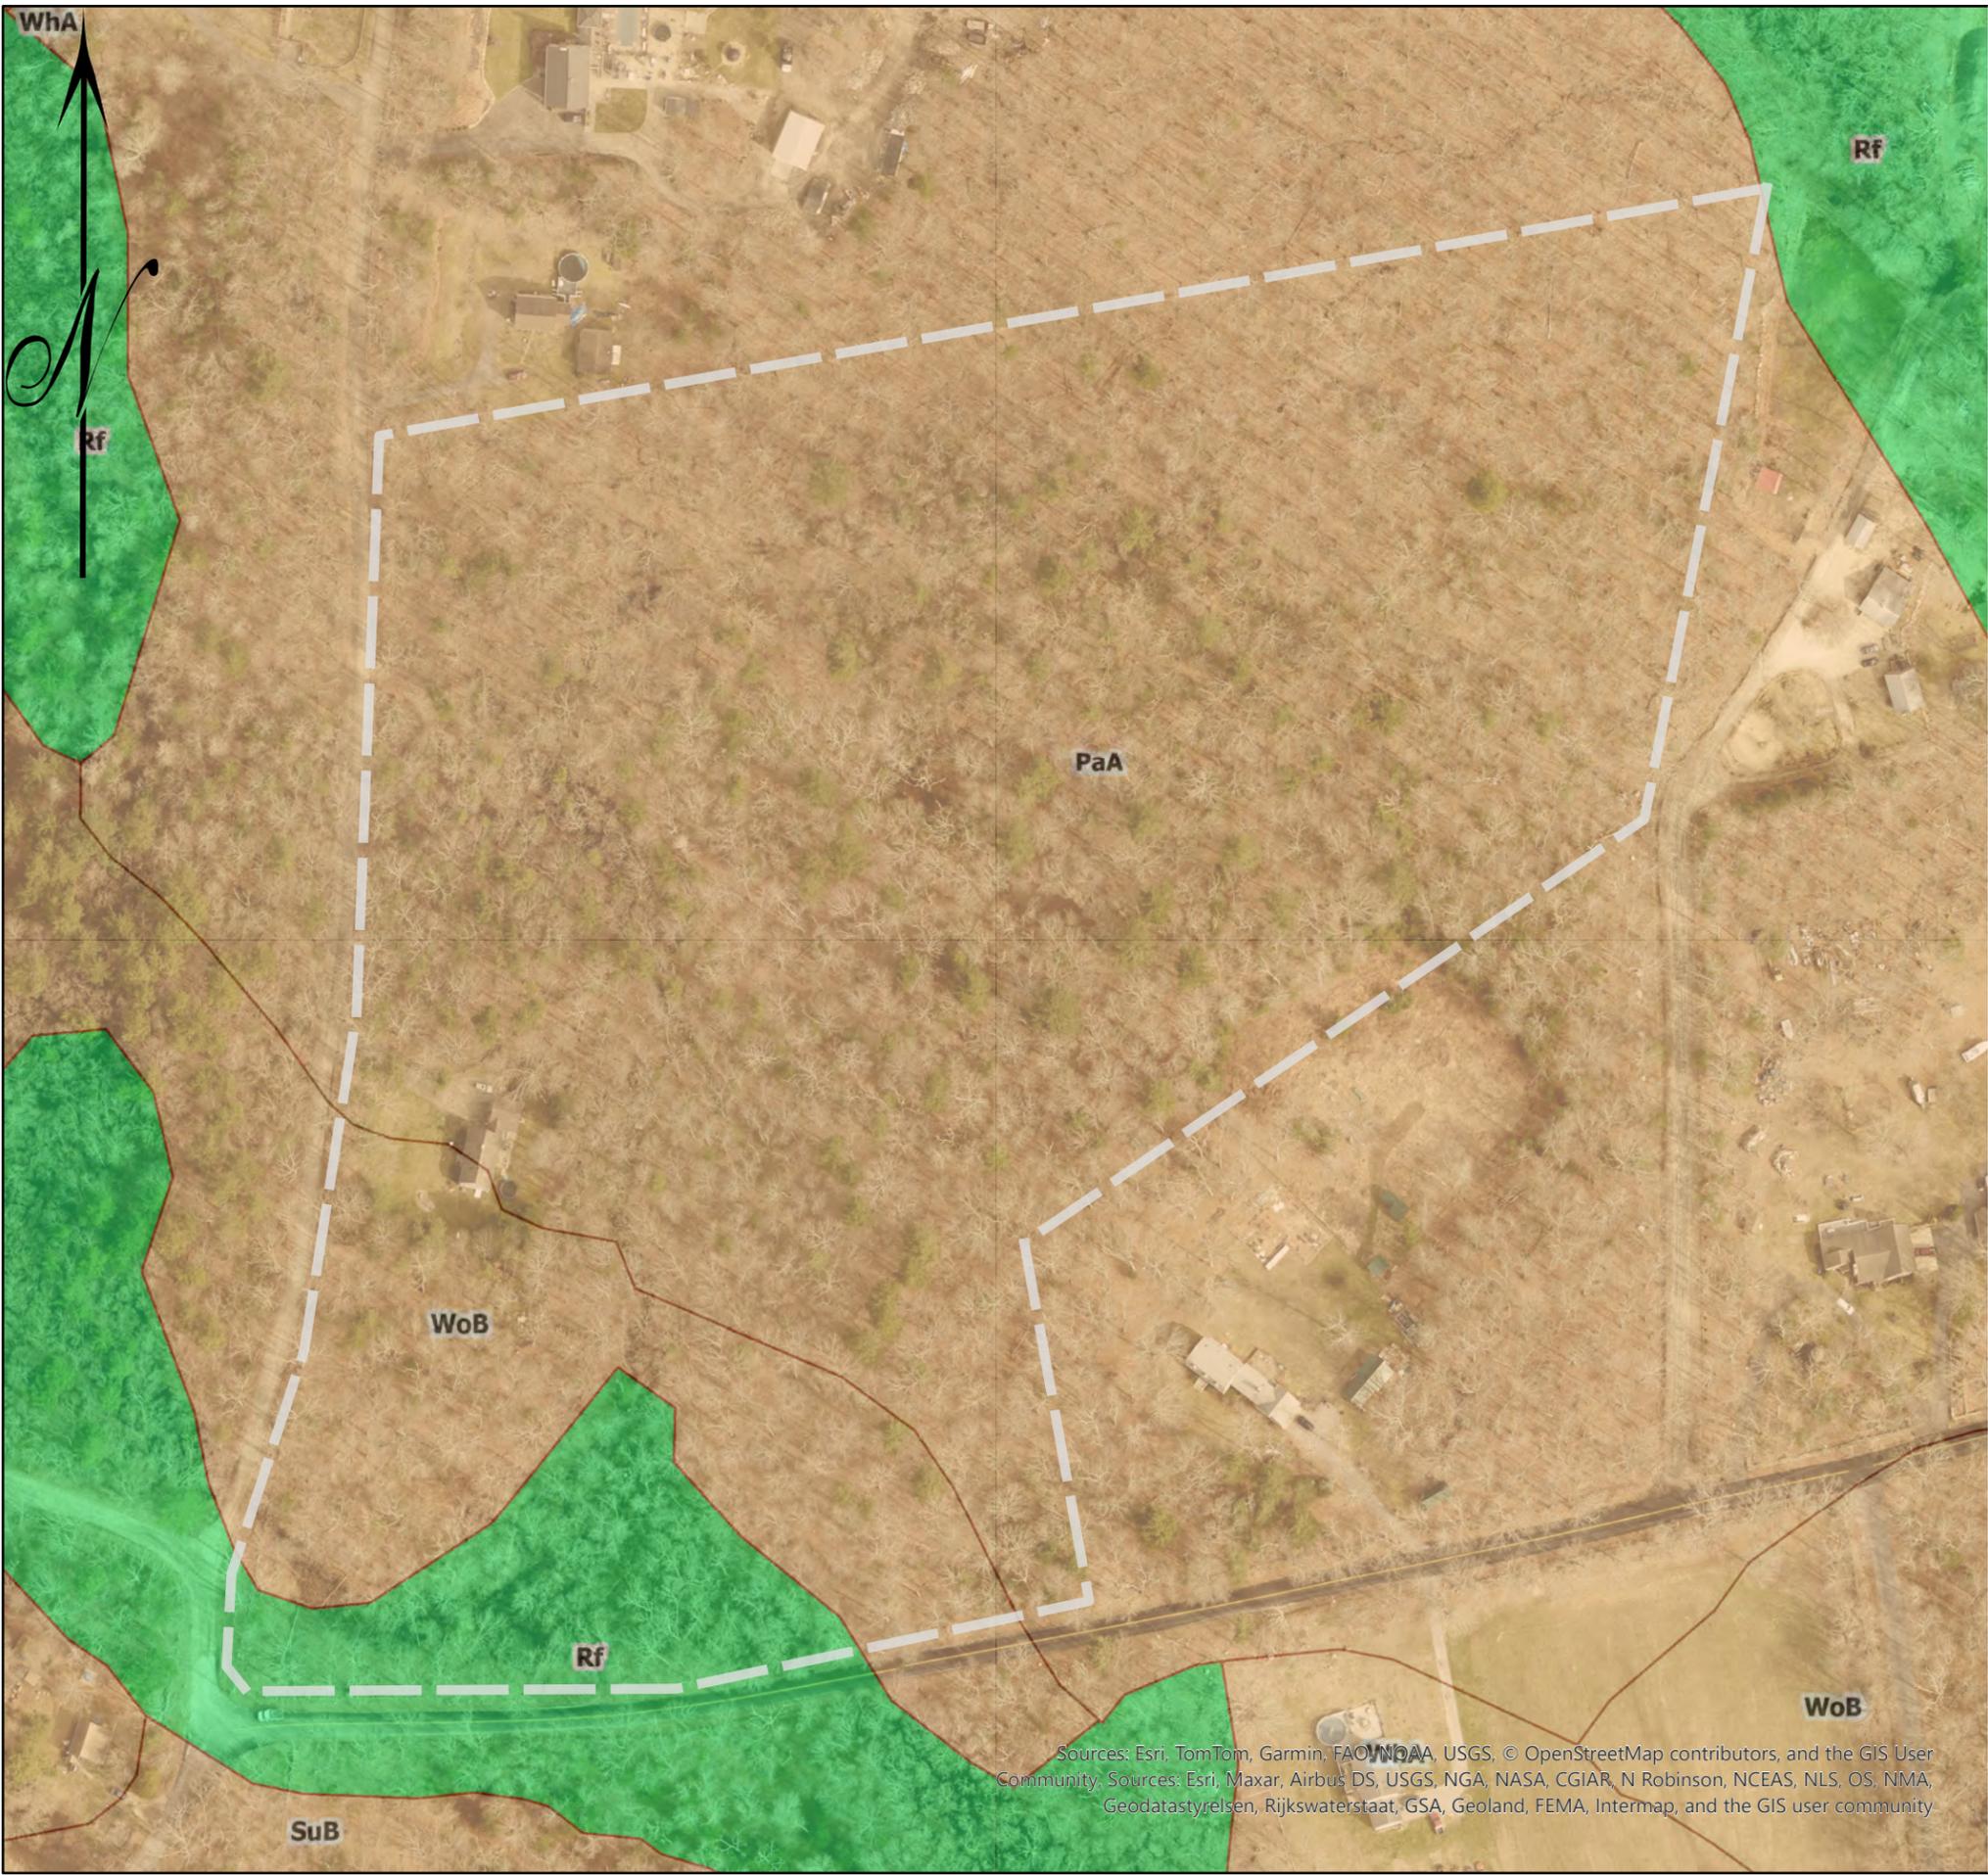
USDA - NRCS SOIL SURVEY MAP
 A.P. 321, Lot 52 | 350 Tillinghast Road
 Coventry, Rhode Island

- PaA - Paxton fine sandy loam, 0 to 3 percent slopes
- Rf - Ridgebury, Leicester, and Whitman soils, 0 to 8 percent slopes, extremely stony
- SuB - Sutton fine sandy loam, 0 to 8 percent slopes, very stony
- WhA - Woodbridge fine sandy loam, 0 to 3 percent slopes
- WoB - Woodbridge fine sandy loam, 0 to 8 percent slopes, very stony

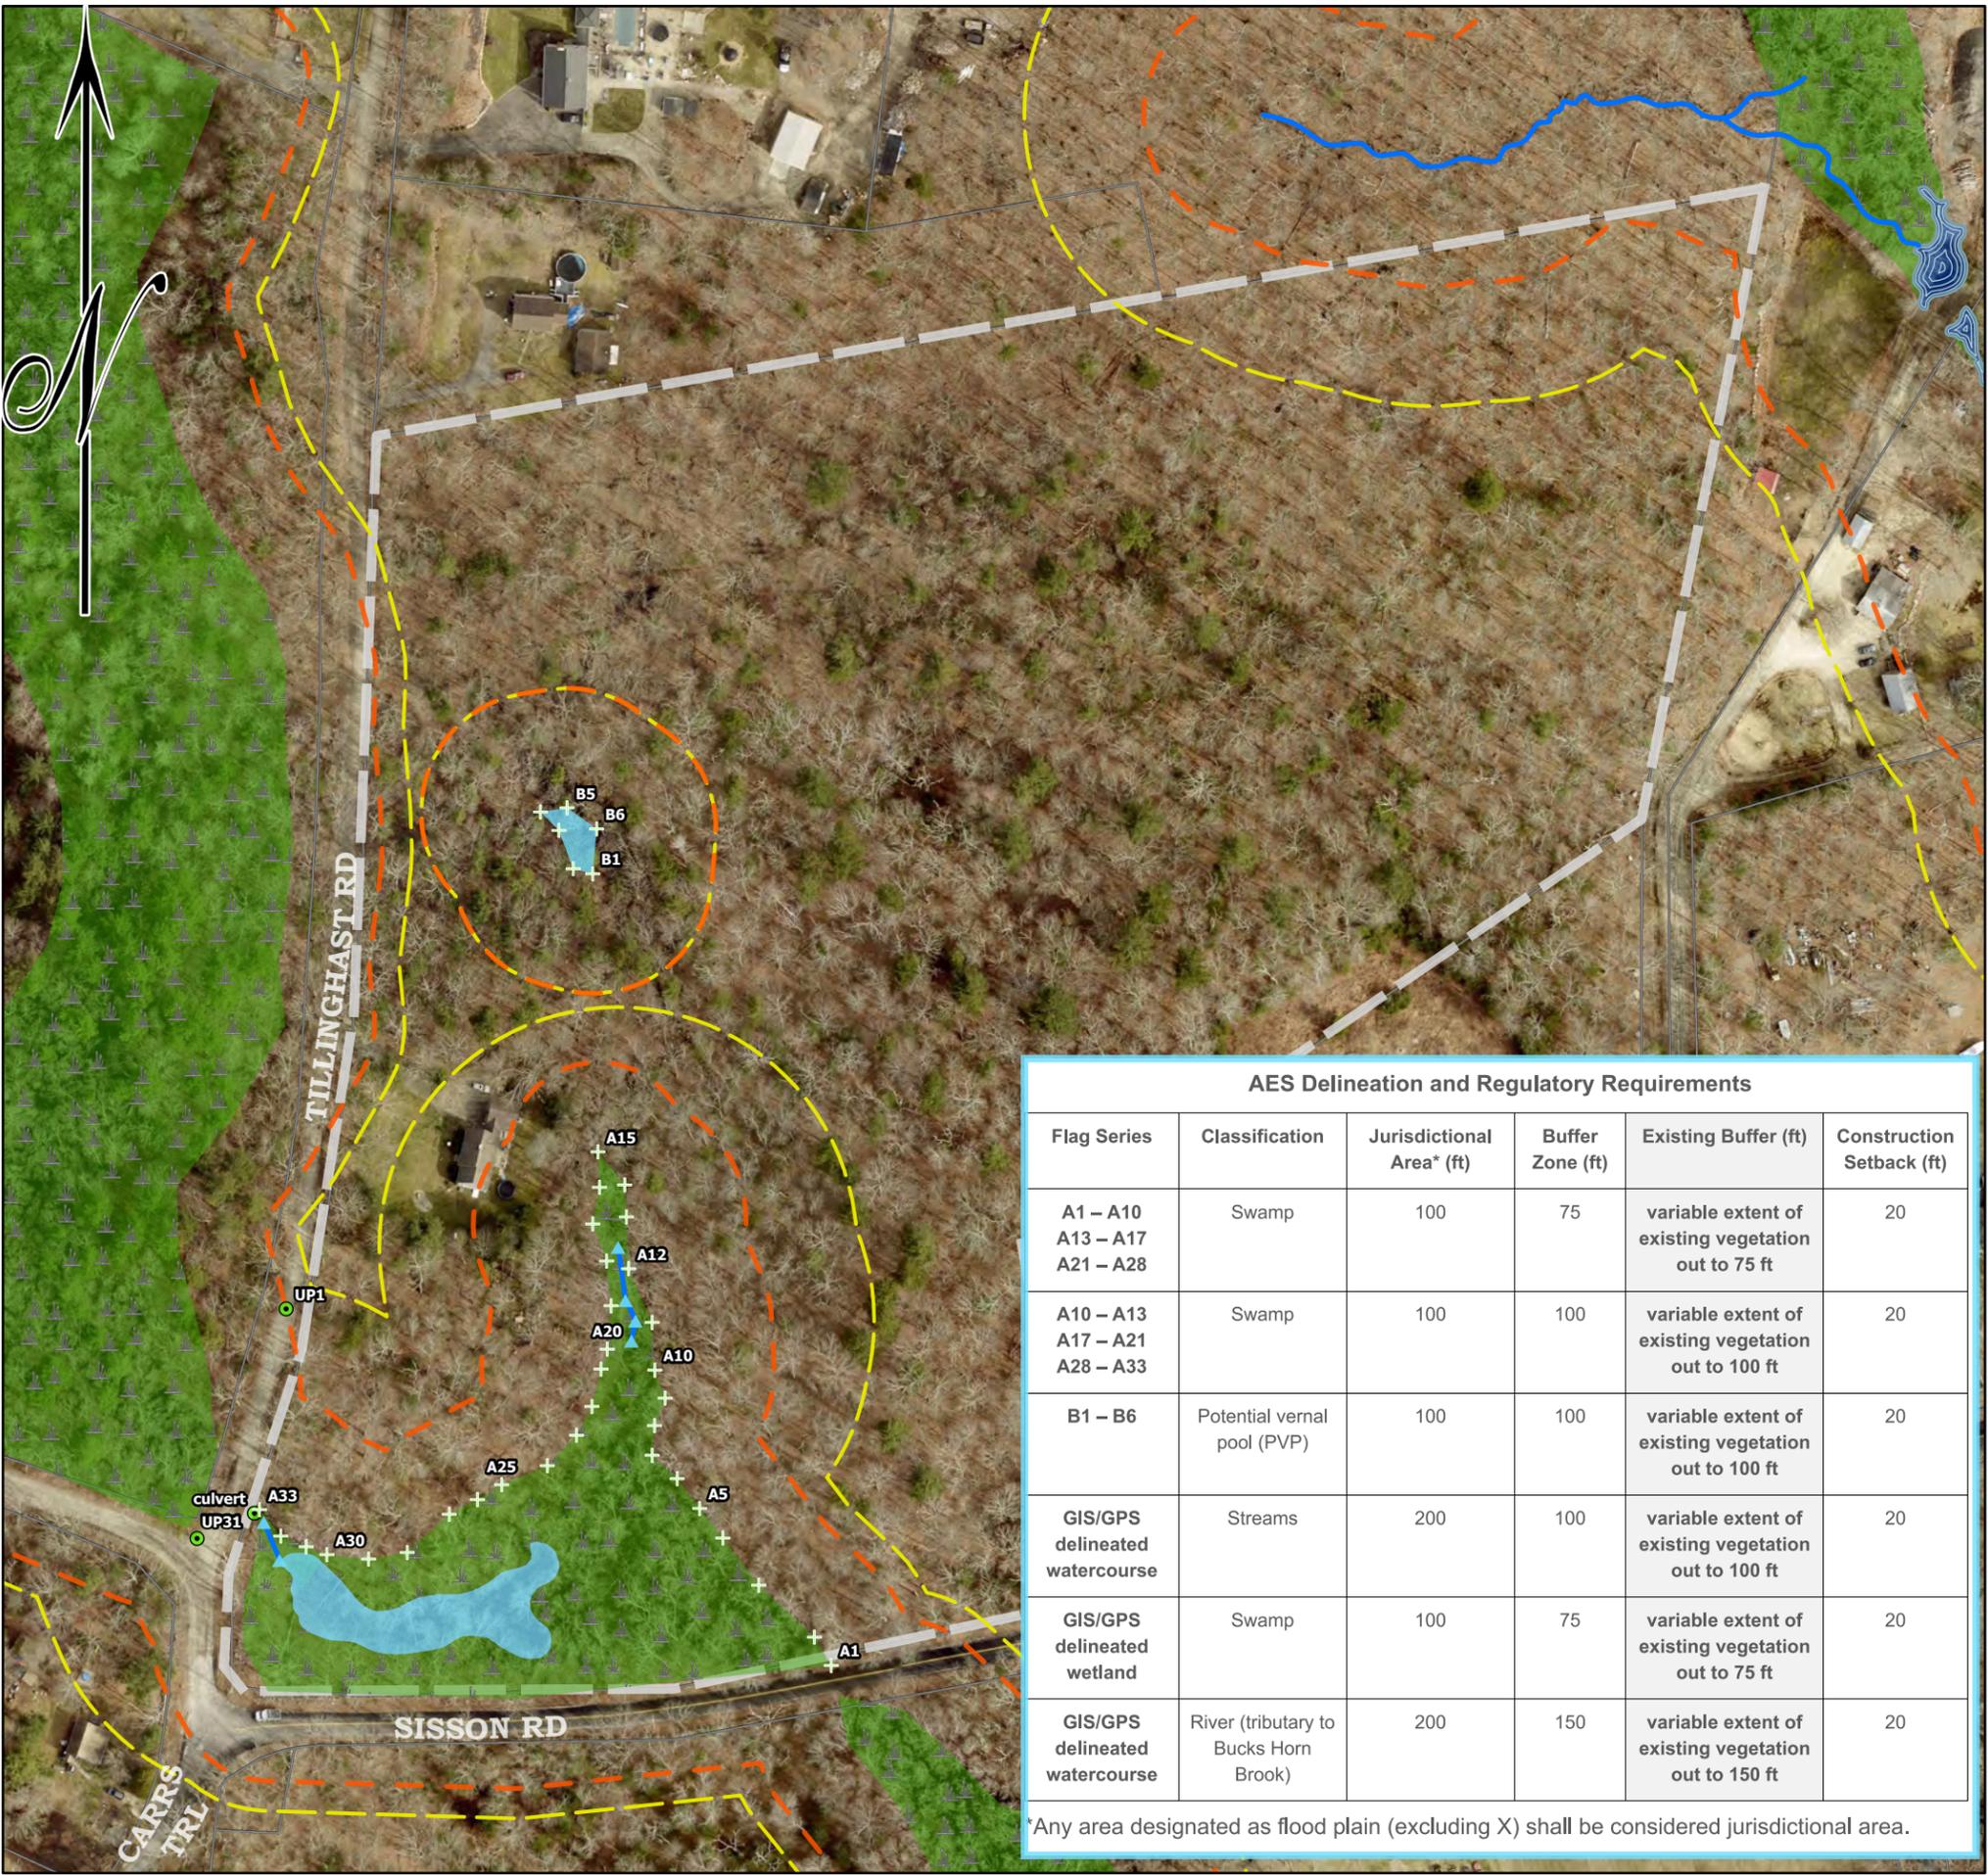
2025 WETLAND DELINEATION MAP
 A.P. 321, Lot 52 | 350 Tillinghast Road
 Coventry, Rhode Island

AES has established two wetland flag series on the property and identified one additional wetland feature. Flagging labeled **A1 – A33** delineates the closest limit of a swamp that covers much of the southern portion of the lot and stretching north towards the center of the site. This swamp also extends to the west and south under the two roadways. Within this swamp are two segments of intermittent streams, both of which were GPS located onsite.

Flagging labeled **B1 – B6** delineates the closest limits of a potential vernal pool (PVP). A second PVP lies within the swamp delineated by the A-series of flags in the southern portion of the lot. A vernal pool is a shallow body of water that fills with rain or snowmelt in the rain or fall that serves as valuable breeding habitat for wildlife. To confirm the presence of a vernal pool, a vernal pool survey must be performed during peak season from late March to mid-May.

Offsite to the northeast flows a tributary to Bucks Horn Brook, along with an associated stream and swamp.

Per section 3.23.F.2., all of these areas are entitled to an additional 25 feet of buffer zone, increasing the total required buffer zone for these regions to 100 feet.

The wetland feature delineated by the B-series of flags is a PVP. Per section 3.23.H.3.i., both this and the PVP within the swamp delineated by the A-series of flags are entitled to a 100-foot buffer zone. If a vernal pool survey performed during peak season (late March to mid-May) determines one of these aren't vernal pools, they will instead be considered swamps and require smaller buffer zones accordingly.

In accordance with 3.23.H.10., the two intermittent streams within the swamp delineated by the A-series of flags, as well as the stream to the northeast associated with the tributary to Bucks Horn Brook, shall each require the application of a 100-foot buffer zone. The tributary to Bucks Horn Brook itself is shown on the USGS Topographic Maps as a blue-lined feature and will therefore be considered a river. Per section 3.23.H.7., this river gets a 150-foot buffer zone.

In addition, a 20-foot construction setback shall be applied to the landward limit of the buffer. Certain construction activities are limited within the setback related to primary structures. Only a 5-foot construction setback pertains to accessory structures (section 3.71.C.1.).
